AMERISPEC[®] INSPECTION SERVICES

Doc #:	82223	Inspector:	Todd Newman
Date:	8/22/2023		
Dwelling Address:	433 S 5th Street Office Building Louisville KY 40202		
Client Name:	Archdiocese of Louisville		
Client's Agent:		Real Estate Company:

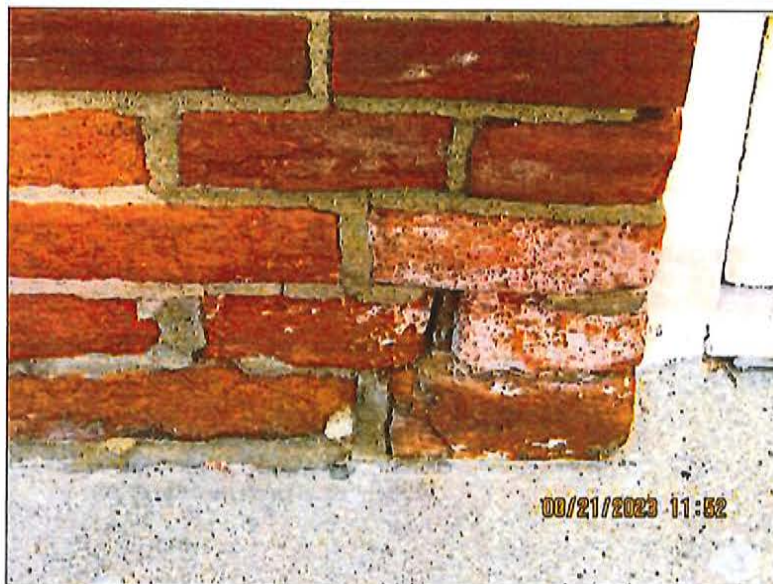
1.0 Item 1(Picture)

Cracked brick and mortar joints observed at front and right side of building. We recommend professionally repairing the affected area to reduce the potential for water infiltration into the home and further displacement.

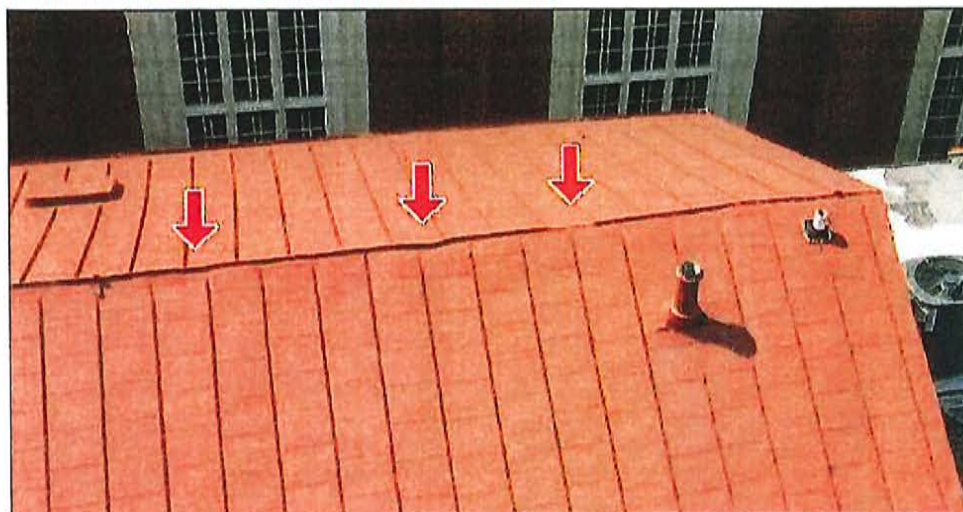
2.0 Item 1(Picture)

Damaged ridge observed. This may be more of a cosmetic concern, or possibly be a water entry issue. Recommend review and repairs as needed by a licensed roofer.

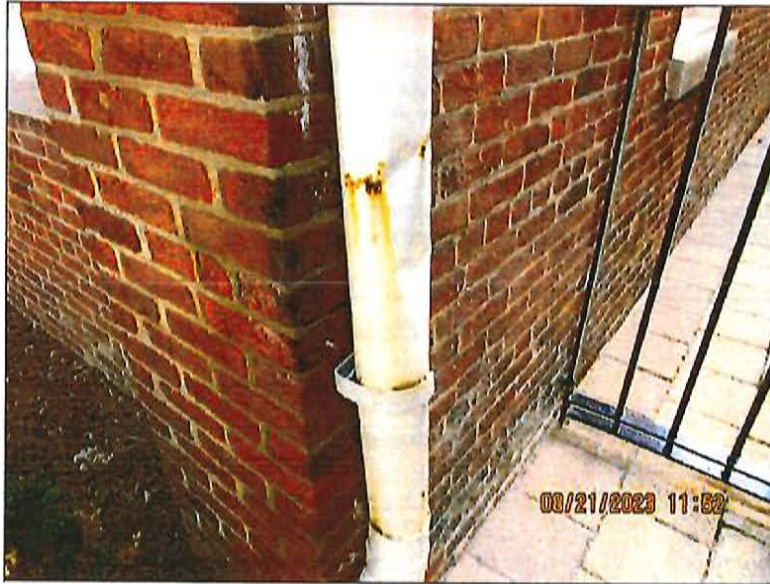
2.2 Item 1(Picture)

Damage observed at front. Recommend review for repair or replacement as necessary.

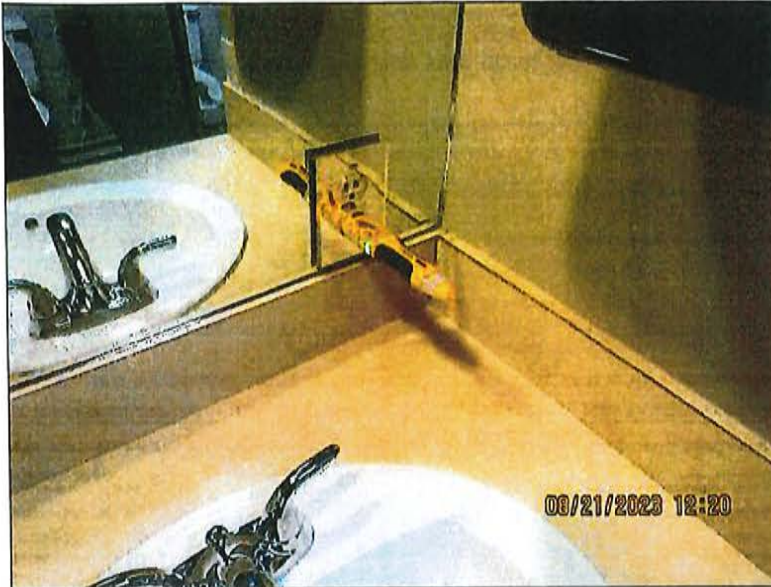
7.7 Item 1(Picture)

A Ground Fault Circuit Interrupter (GFCI) is not present in the mens and women's bathrooms at first floor. Suggest installing GFCI for safety. A qualified electrical contractor is needed for further review and to make necessary repairs/corrections

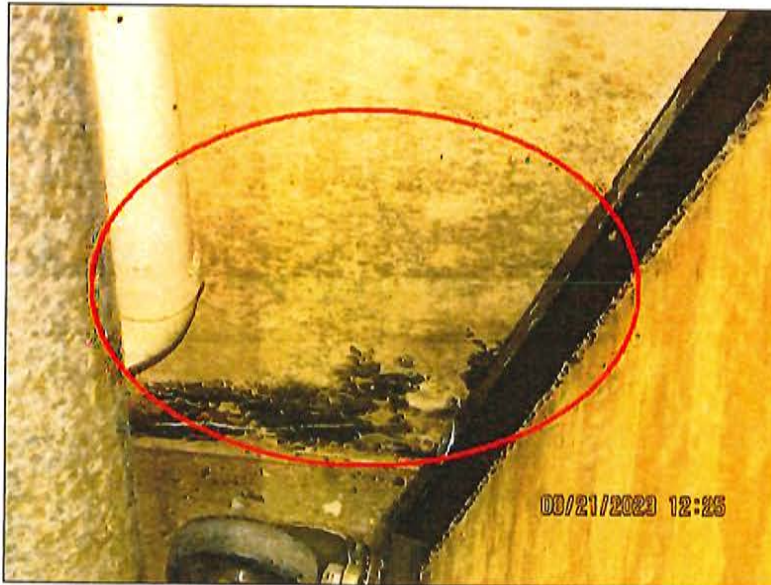
8.1 Item 1(Picture)

Stains, discoloration, growth and/or evidence of moisture observed in the HVAC closet on first floor. These conditions may indicate mold and/or fungus growth and were discovered during the home inspection. Because certain types of mold may be toxic and result in adverse health effects, it is strongly recommended that a mold inspection be performed by a qualified professional to determine the presence of, and types of, mold in the house and that corrective measures be taken to limit moisture inside the home. AmeriSpec does offer mold and air quality testing services if client would like additional information.

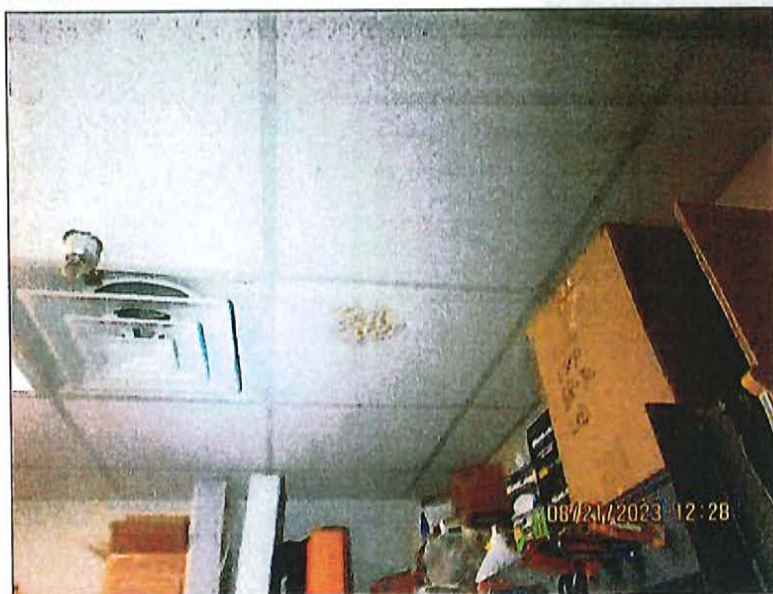
8.2 Item 1(Picture)

Due to recent dry conditions the inspector is unable to determine if stains are active or passive in the storage room. This also may be from condensation from ductwork above. Recommend review and repairs as needed by a qualified contractor.

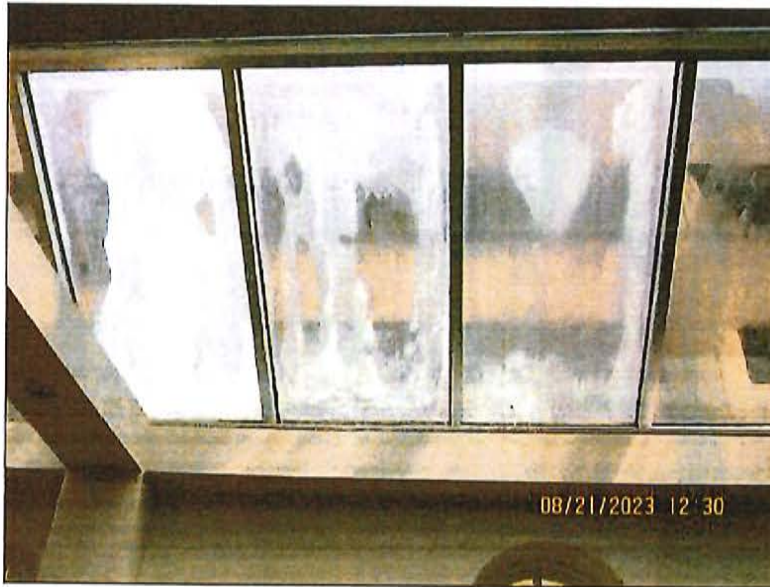
8.5 Item 1(Picture)

(1) Fog and condensation was noted in the double glazed insulated window panes in the entry way and rear second floor window. This indicates a broken seal which will reduce visibility and the insulating capability of this window. To restore visibility and regain the insulating capability, replacement of this window pane is required.

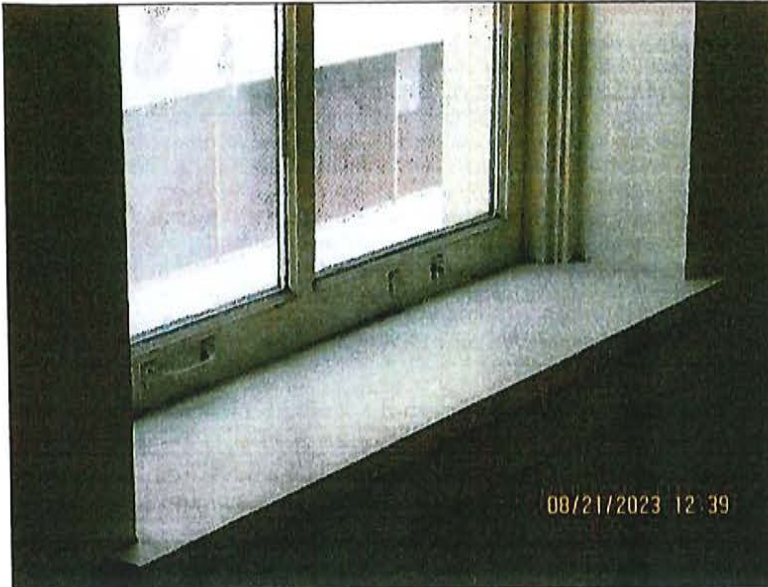
8.5 Item 3(Picture)

(2) Windows in various rooms of the building were difficult to operate. This may be from the lack of use over time or other issues. We recommend having all windows reviewed by a window specialist for proper operation and safety.

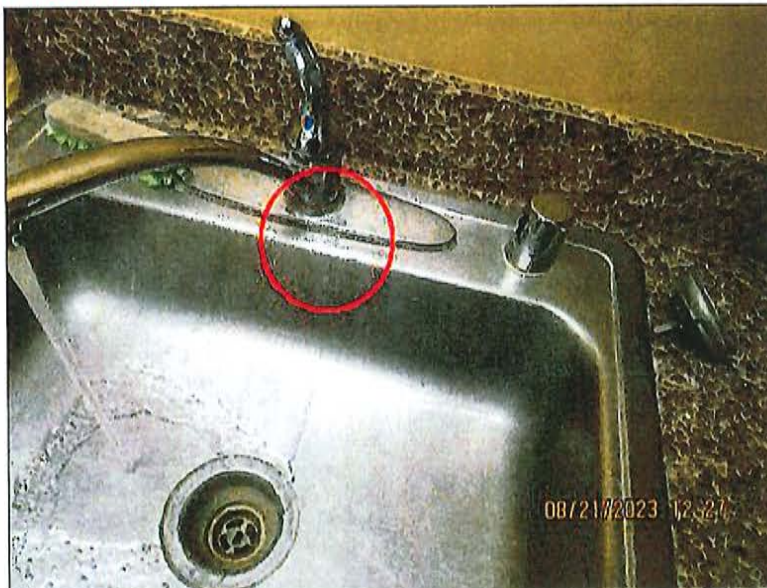
8.8 Item 1(Picture)

Faucet leaks at break room on first floor. Recommend review by Licensed/Qualified plumber for repair or replacement as necessary.

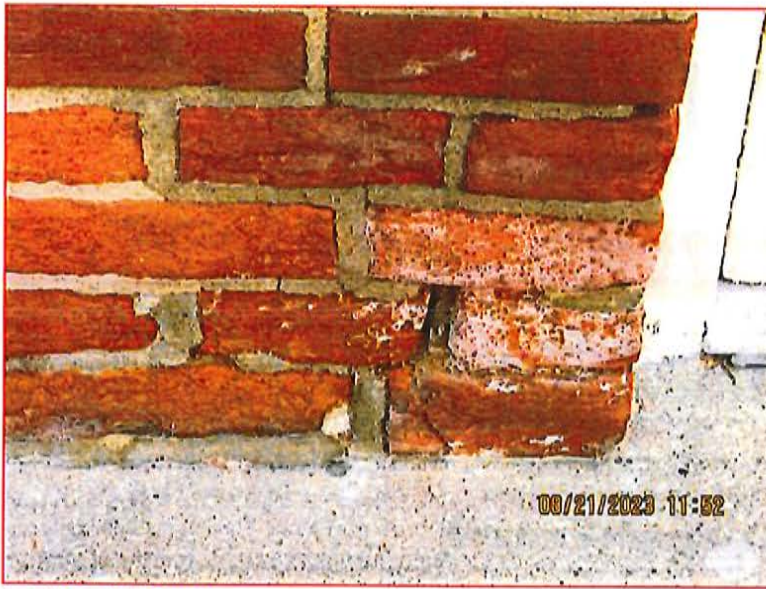
1.0 Item 1(Picture)

Cracked brick and mortar joints observed at front and right side of building. We recommend professionally repairing the affected area to reduce the potential for water infiltration into the home and further displacement.

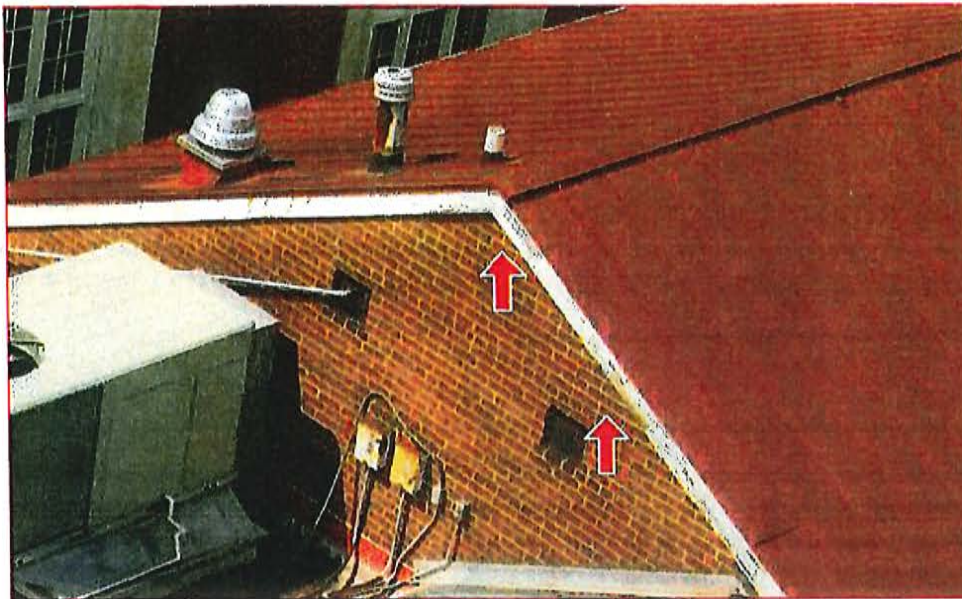
1.1 Item 1(Picture)

Peeling paint observed at various locations; suggest scraping and painting as necessary as part of normal maintenance.

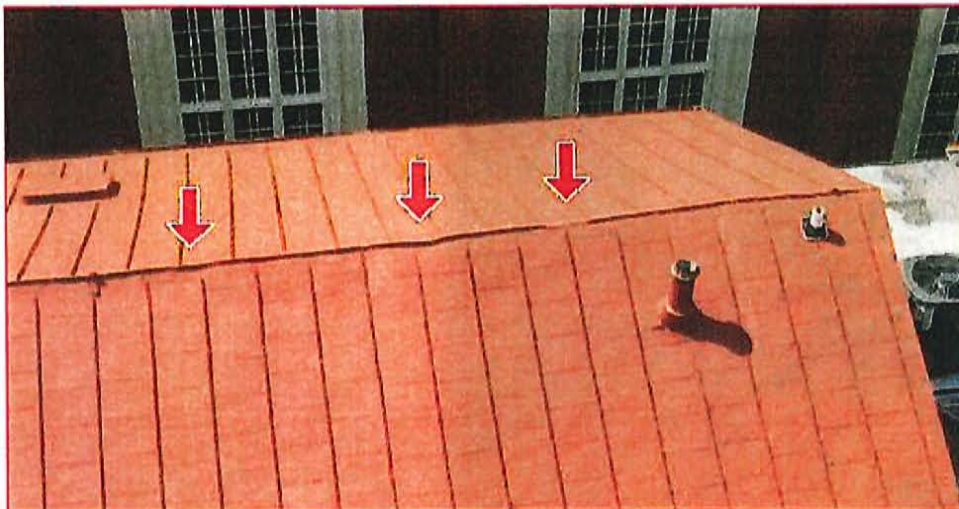
2.0 Item 1(Picture)

Damaged ridge observed. This may be more of a cosmetic concern, or possibly be a water entry issue. Recommend review and repairs as needed by a licensed roofer.

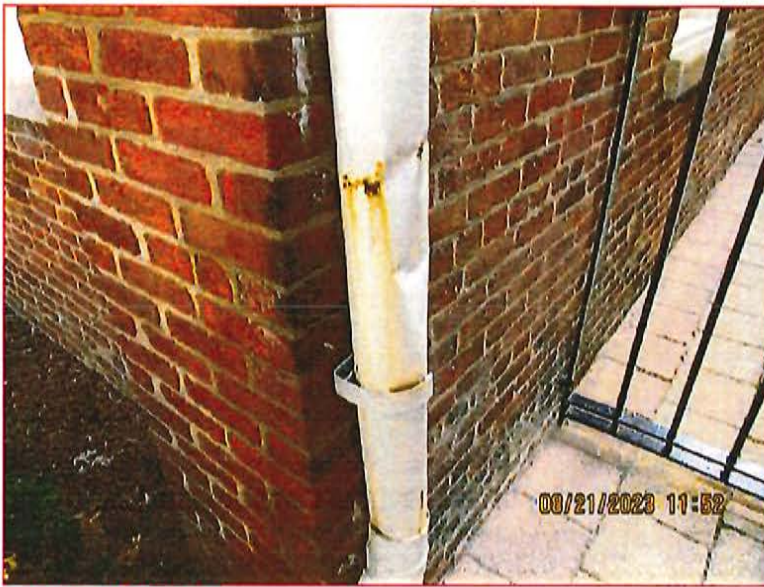
2.2 Item 1(Picture)

Damage observed at front. Recommend review for repair or replacement as necessary.

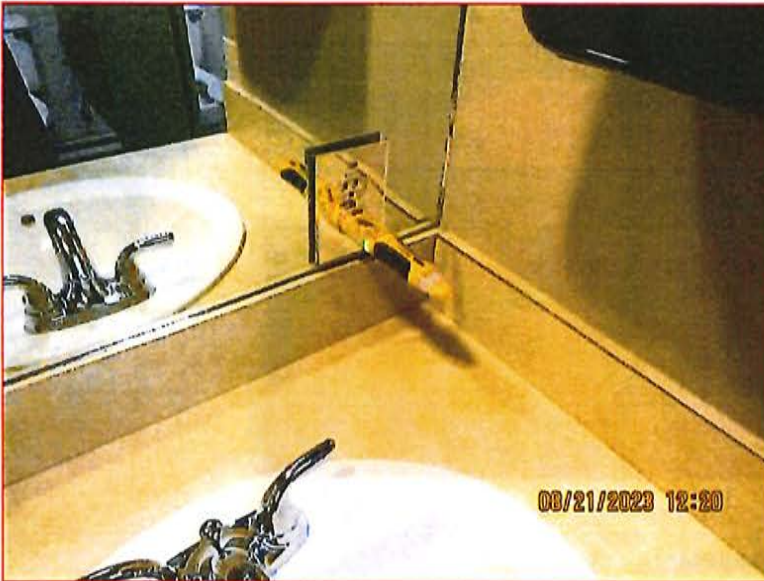
7.7 Item 1(Picture)

A Ground Fault Circuit Interrupter (GFCI) is not present in the mens and women's bathrooms at first floor. Suggest installing GFCI for safety. A qualified electrical contractor is needed for further review and to make necessary repairs/corrections

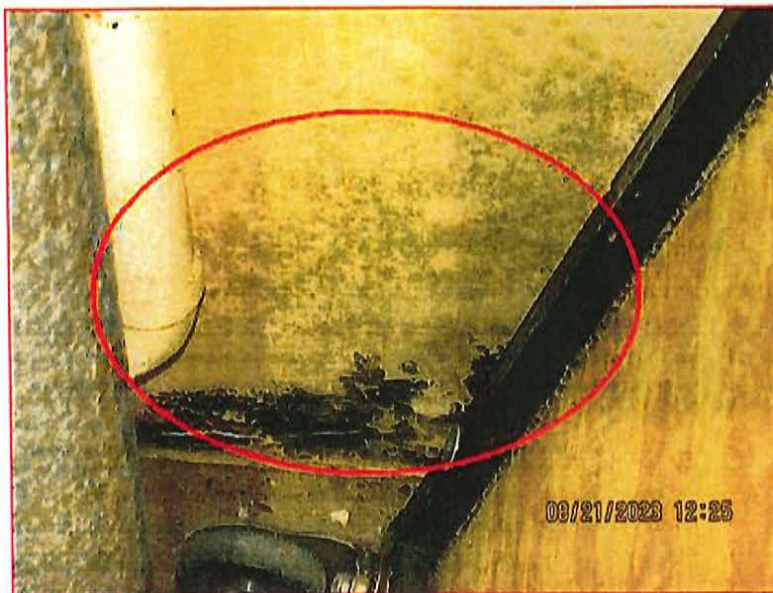
8.1 Item 1(Picture)

Stains, discoloration, growth and/or evidence of moisture observed in the HVAC closet on first floor. These conditions may indicate mold and/or fungus growth and were discovered during the home inspection. Because certain types of mold may be toxic and result in adverse health effects, it is strongly recommended that a mold inspection be performed by a qualified professional to determine the presence of, and types of, mold in the house and that corrective measures be taken to limit moisture inside the home. AmeriSpec does offer mold and air quality testing services if client would like additional information.

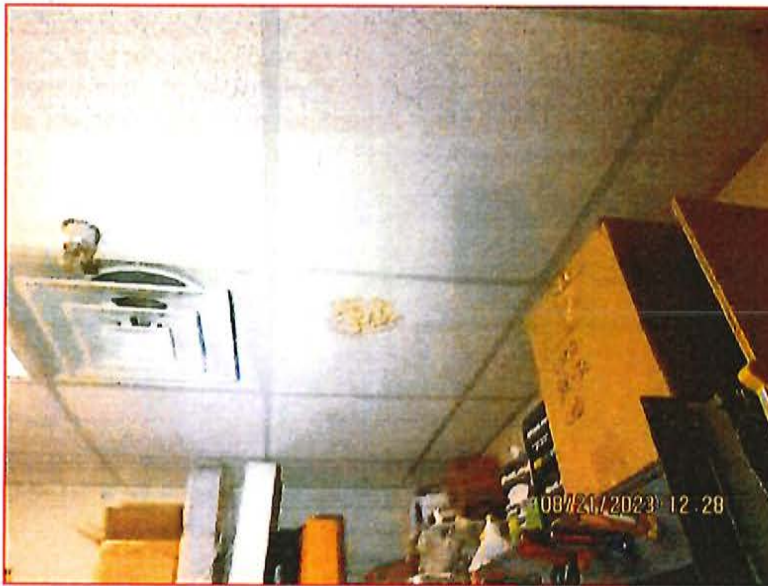
8.2 Item 1(Picture)

Due to recent dry conditions the inspector is unable to determine if stains are active or passive in the storage room. This also may be from condensation from ductwork above. Recommend review and repairs as needed by a qualified contractor.

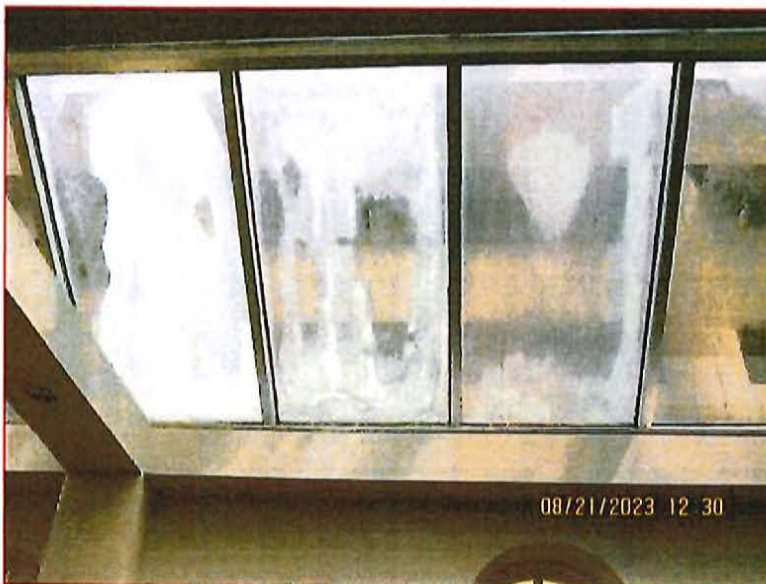
8.5 Item 1(Picture)

(1) Fog and condensation was noted in the double glazed insulated window panes in the entry way and rear second floor window. This indicates a broken seal which will reduce visibility and the insulating capability of this window. To restore visibility and regain the insulating capability, replacement of this window pane is required.

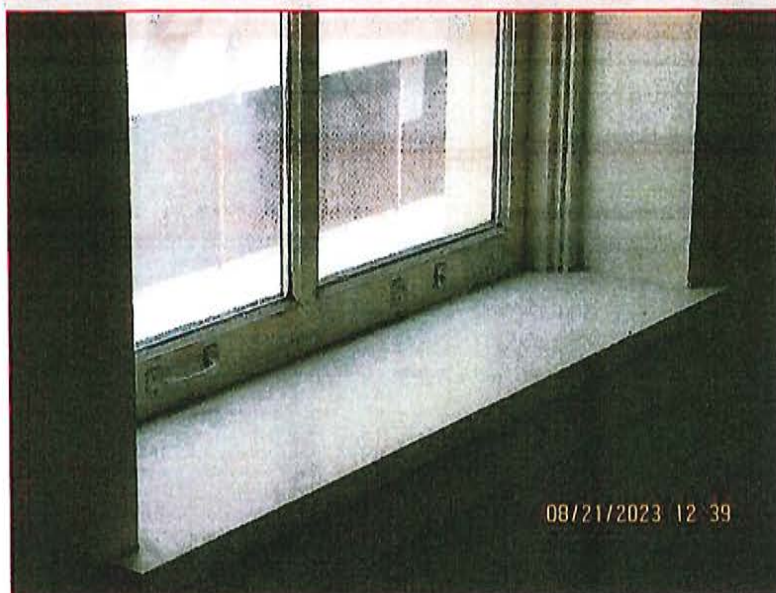
8.5 Item 3(Picture)

(2) Windows in various rooms of the building were difficult to operate. This may be from the lack of use over time or other issues. We recommend having all windows reviewed by a window specialist for proper operation and safety.
