AMERISPEC[®] INSPECTION SERVICES

Doc #:	82223D	Inspector:	Todd Newman
Date:	8/23/2023		
Dwelling Address:	424 S. 5th Street PATTERSON HISTORY CENTER Louisville KY 40202		
Client Name:	Archdiocese of Louisville		
Client's Agent:		Real Estate Company:

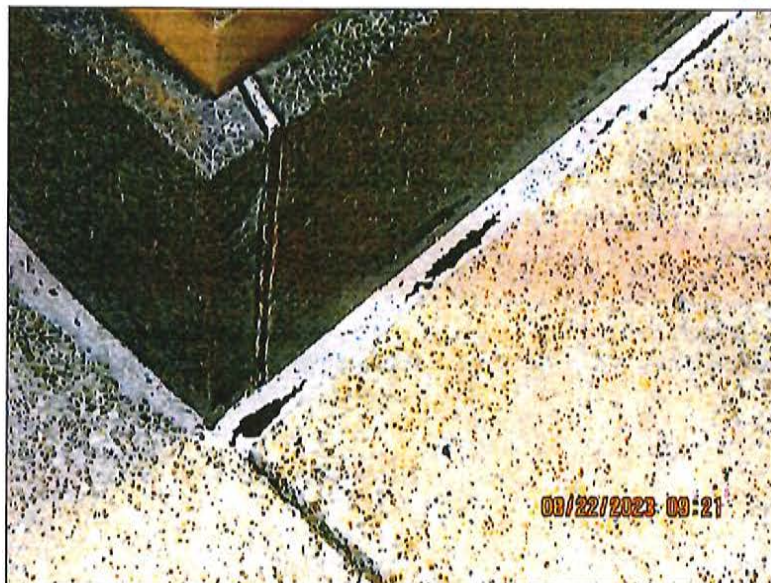
1.1 Item 1(Picture)

(1) Caulking should be applied around all windows, doors, and any voids where necessary.

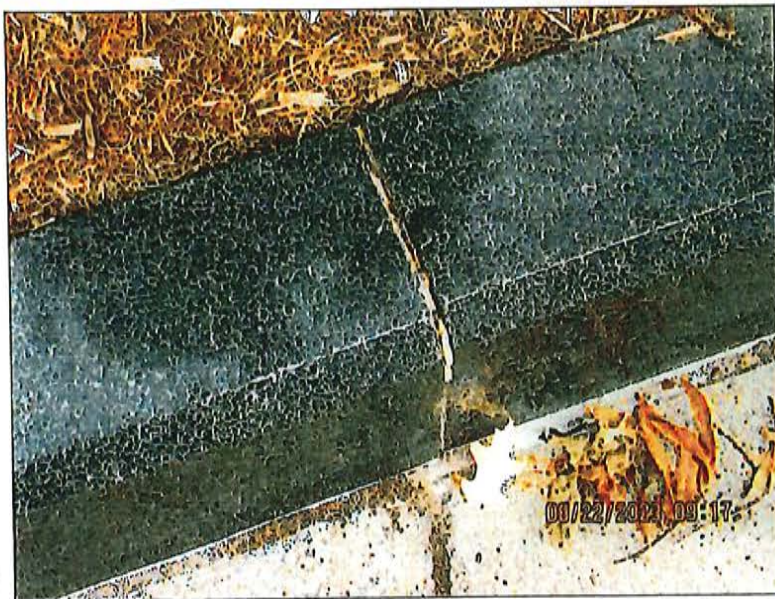
1.1 Item 3(Picture)

(2) Damaged/deteriorated grout, mortar observed at front and rear of building. Recommend repairs to prevent further damage.

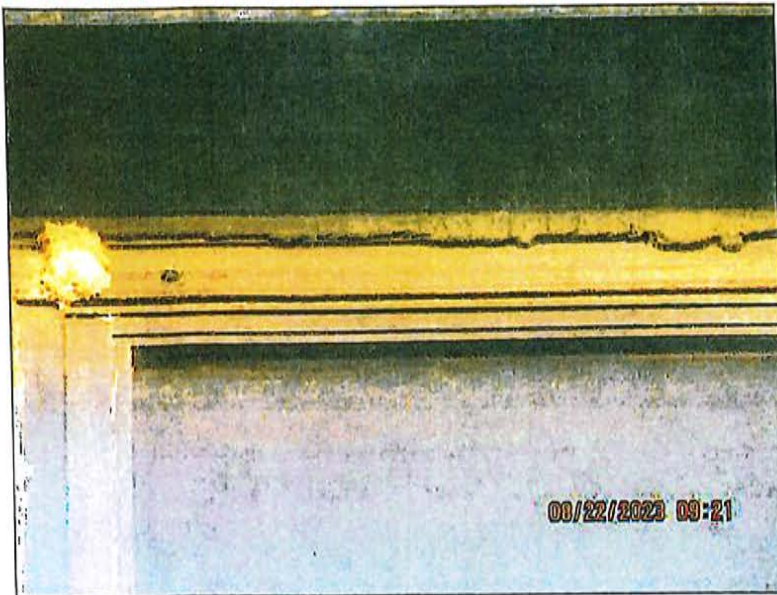
1.2 Item 1(Picture)

Dried, damaged caulking observed at various window. Recommend repairs as needed by a qualified contractor.

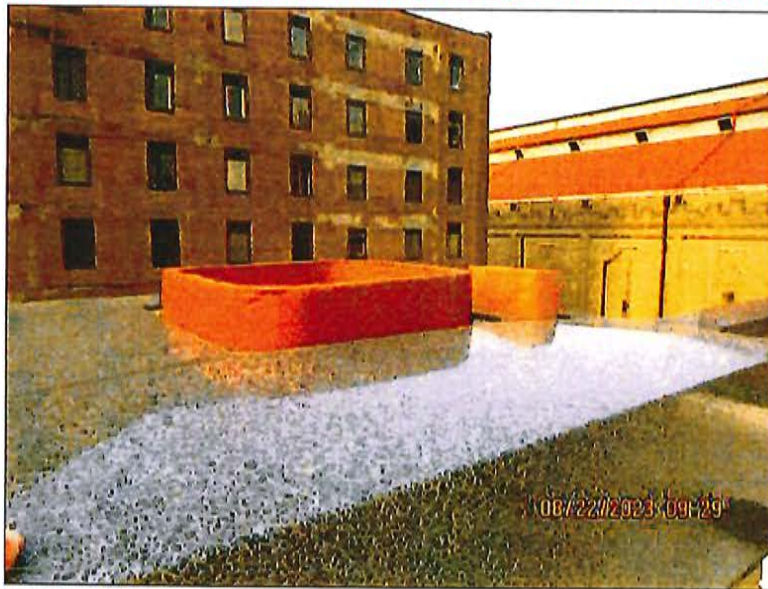
3.3 Item 1(Picture)

No chimney rain cap observed, suggest installing a chimney rain cap to prevent the entrance of the elements, local wildlife, and to preserve the life of the chimney as well as minimize maintenance.

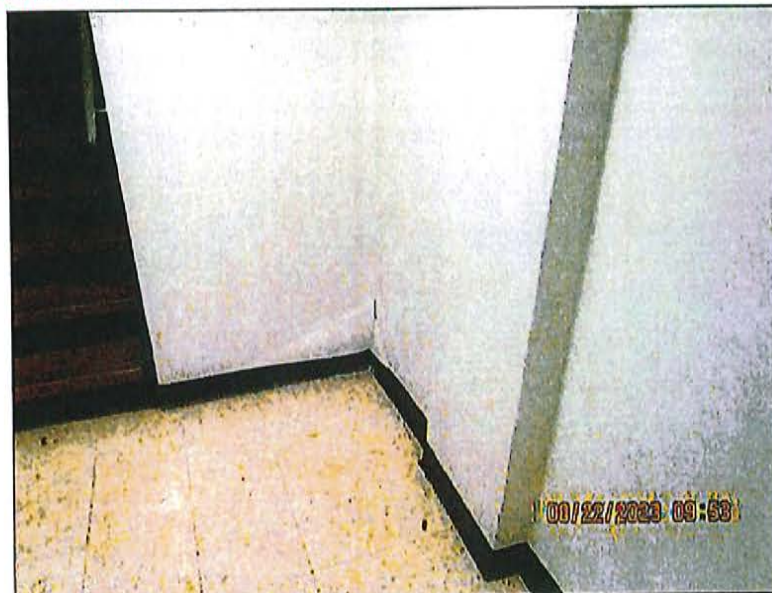
5.3 Item 1(Picture)

Damaged drywall observed in the basement. Recommend review by a Licensed/Qualified professional contractor for repair or replacement as necessary.

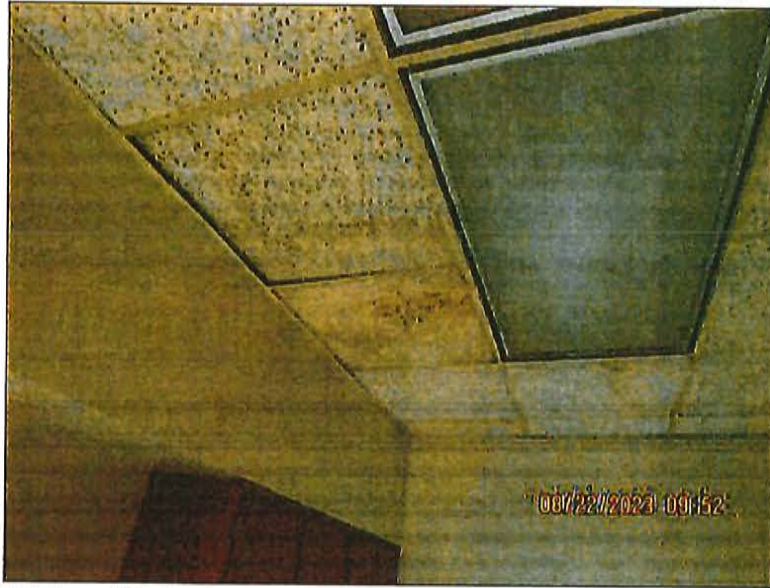
5.4 Item 1(Picture)

Stains observed on the ceiling in the basement. An elevated level of moisture was detected using an electronic moisture meter. A qualified contractor is needed for further review and to perform necessary corrections prior to close.

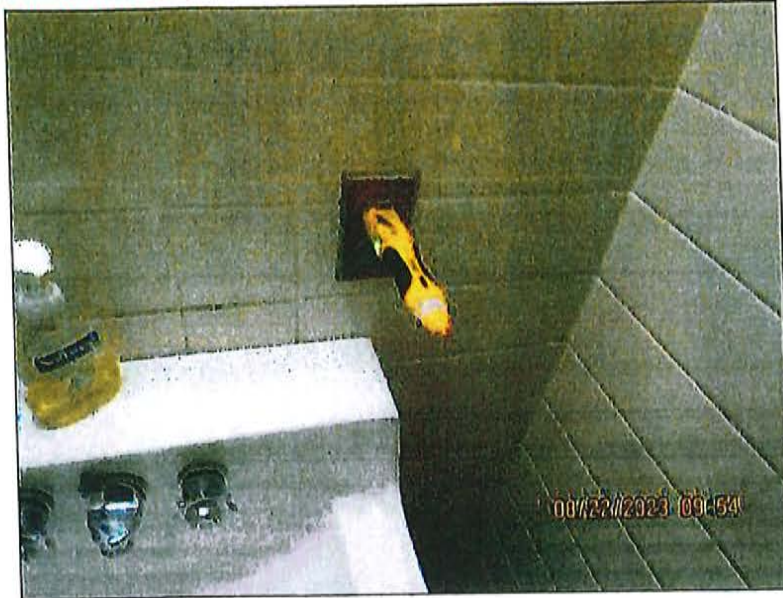
5.10 Item 1(Picture)

Not all receptacles are ground fault circuit interrupter (GFCI) protected. This may not have been required when building was built; client is advised to install ground fault circuit interrupter outlets as a safety enhancement.

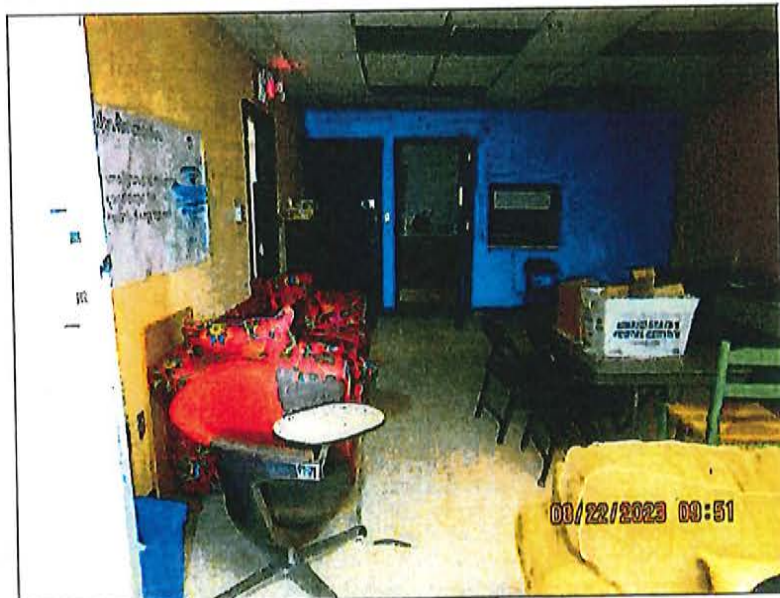
5.15 Item 1(Picture)

Possible asphalt Asbestos observed on basement flooring. Plastic Asbestos, and Vinyl Asbestos floor tiles were sold in 6"x6", 9" x 9" and in some years 12" x 12" sizes. Recommend review for possible removal if client is concerned.

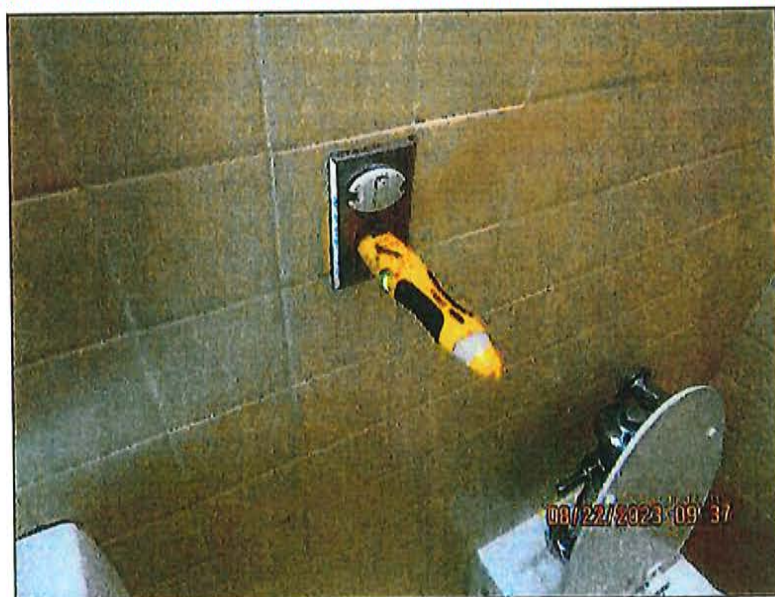
7.7 Item 1(Picture)

A Ground Fault Circuit Interrupter (GFCI) is not present in all upstairs bathrooms, suggest installing GFCI for safety. A qualified electrical contractor is needed for further review and to make necessary repairs/corrections

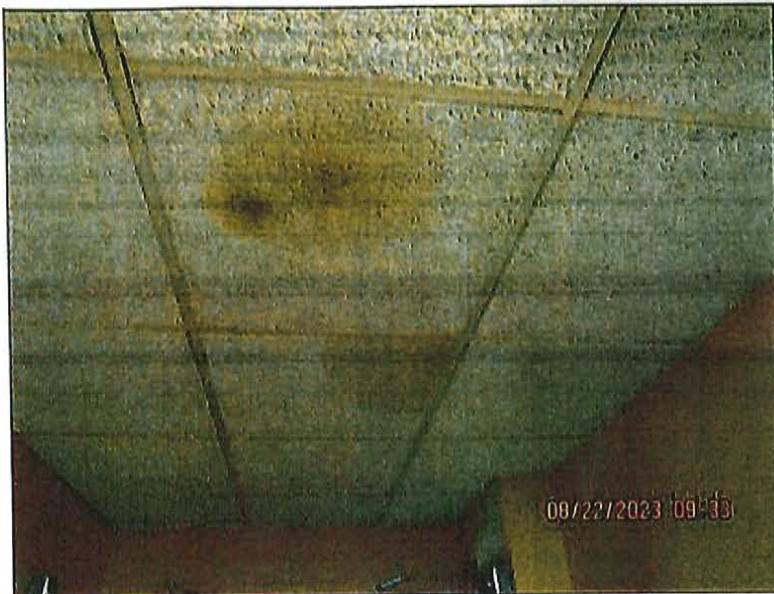
8.2 Item 1(Picture)

Stains observed on ceiling in the 2nd floor hallway. The Inspector checked the stains with pin-less non-invasive moisture detector, which showed no moisture present at time of inspection. Client is advised to consult seller to determine the source of staining and verify that corrections have been made.

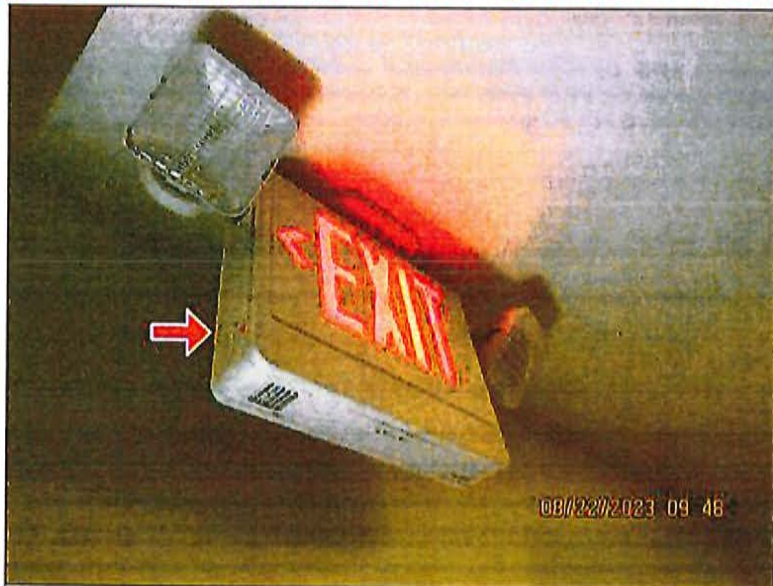
8.7 Item 1(Picture)

Test button at exit did not respond to test. Most likely this is a result of a spent battery. Recommend replacing for safety.

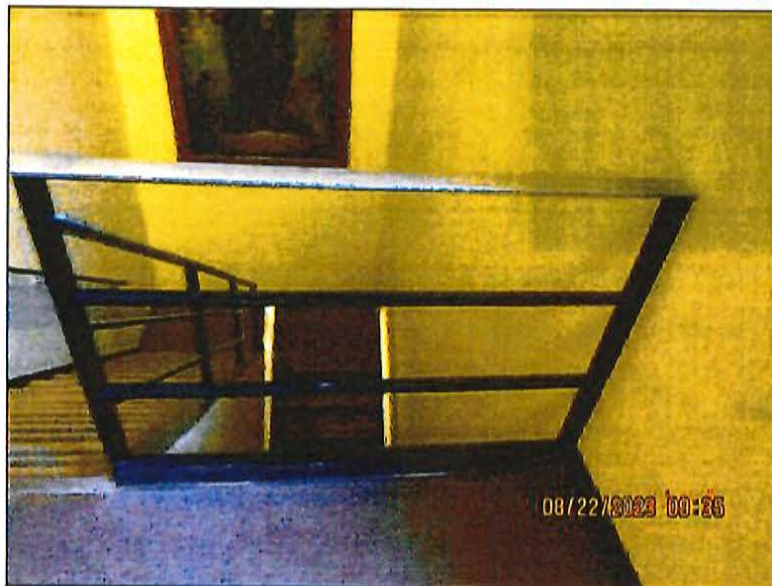
8.10 Item 1(Picture)

Spacing between rails appears larger than 4 inches which may allow small children to crawl through the space. This was observed at stairwell areas. Client may wish to reduce spacing as a child safety enhancement.

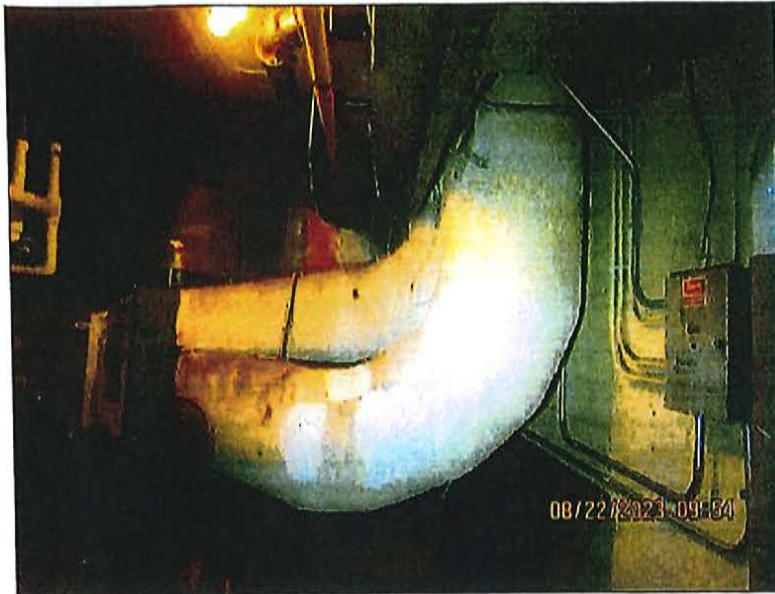
10.5 Item 1(Picture)

Possible asbestos materials observed. The materials appeared to be intact at the time of inspection. Asbestos materials are considered safe by the EPA if they are not disturbed, torn, ripped, or damaged. No torn, ripped, or damaged materials were observed. If client has any concerns regarding asbestos materials, an asbestos testing lab should be consulted for further review to ensure safety.

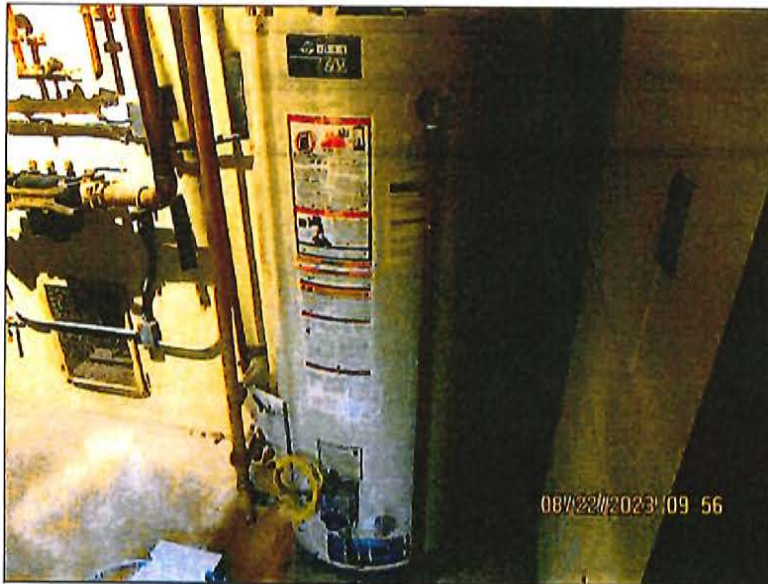
11.0 Item 1(Picture)

The system did operate although isn't a guarantee of future operation. Due to the age of this unit (2003), this system may be at the end of it's useful life. A maintenance and performance evaluation should be performed. It is recommended that a qualified licensed plumber service review this system.

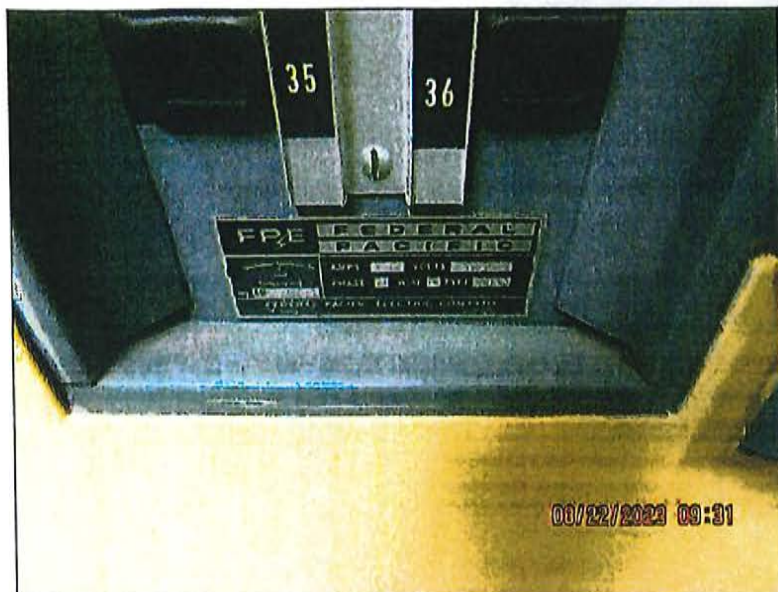
14.2 Item 1(Picture)

(2) You have a Federal Pacific panel which is legal, but there is a possibility that the circuit breakers may not trip when shorted possibly causing an electrical hazard. These were installed in residential and commercial applications. 5 panels were discovered. Federal Pacific is no longer in business. Opinions by licensed electrical contractors on this panel varies between safe and unsafe. I recommend you consult a licensed electrical contractor for an opinion and correct if necessary.

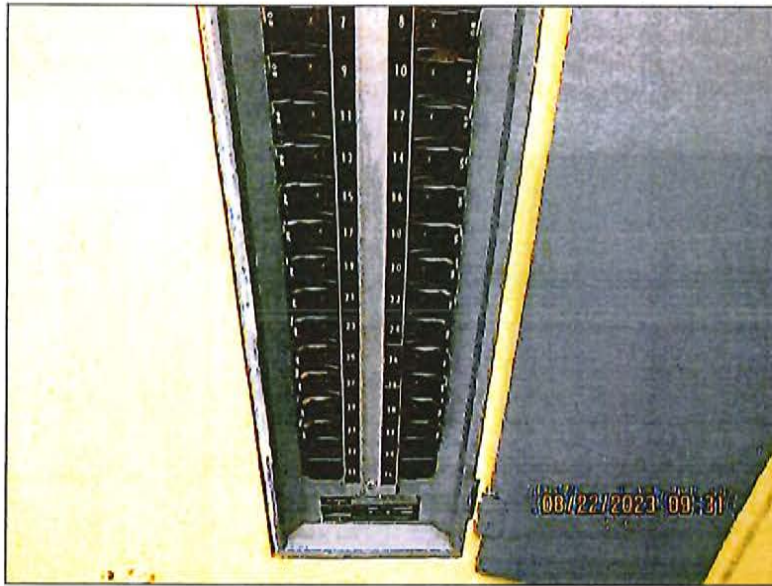
14.2 Item 2(Picture)

- A Federal Pacific Electric (FPE) service panel and circuit breakers were noted in this building. The Consumer Product Safety Commission (CPSC) conducted a two-year investigation into the safety of FPE circuit breakers and concluded that the data currently available to it did not establish that the circuit breakers present a serious risk of injury to consumers. There were reports that the circuit breakers failed to trip in some overloaded conditions, creating a serious fire hazard. The CPSC indicated that it would cost several million dollars to gather the data necessary to fully assess the safety risks posed by the circuit breakers and decided not to commit further resources to its investigation. Because of the reports indicating that the circuit breakers may fail to trip, we recommend that the FPE service panel be reviewed by a licensed electrician to ensure proper and safe operation. For more information regarding FPE panels, consumers can contact the CPSC at 800-638-2772 or visit their website at <http://www.cpsc.gov/>.

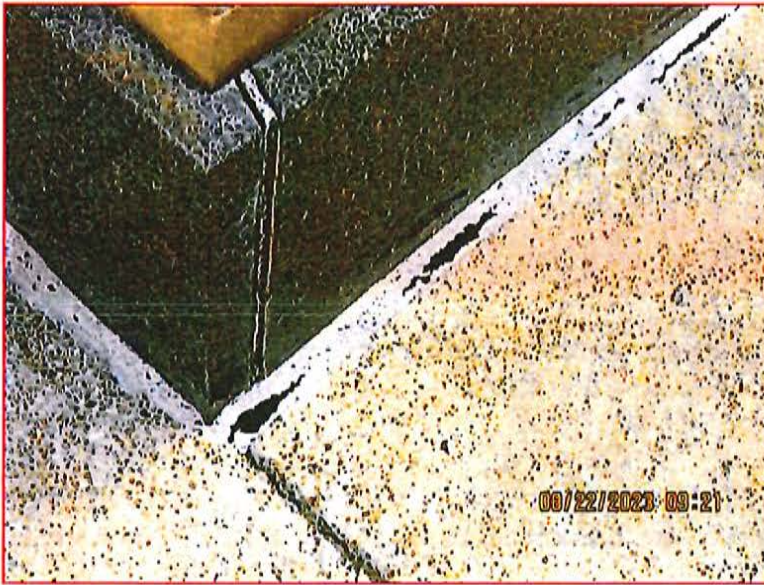
1.1 Item 1(Picture)

(1) Caulking should be applied around all windows, doors, and any voids where necessary.

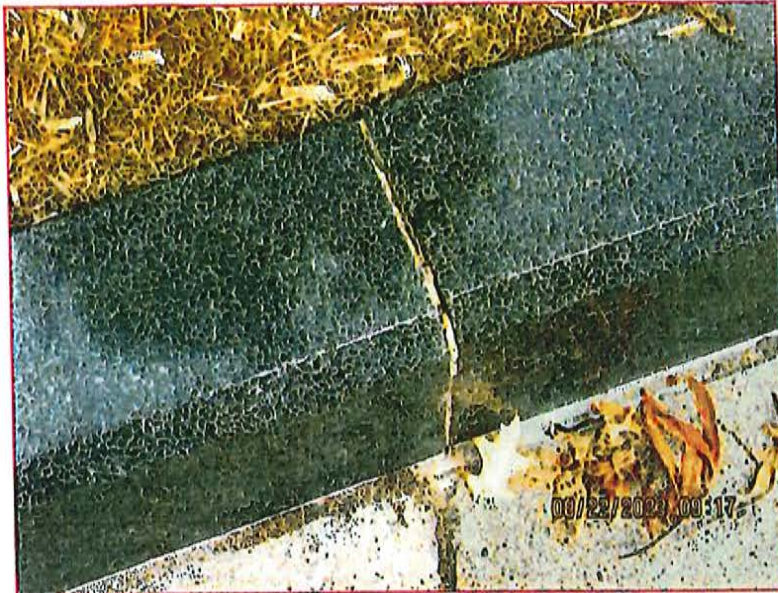
1.1 Item 3(Picture)

(2) Damaged/deteriorated grout, mortar observed at front and rear of building. Recommend repairs to prevent further damage.

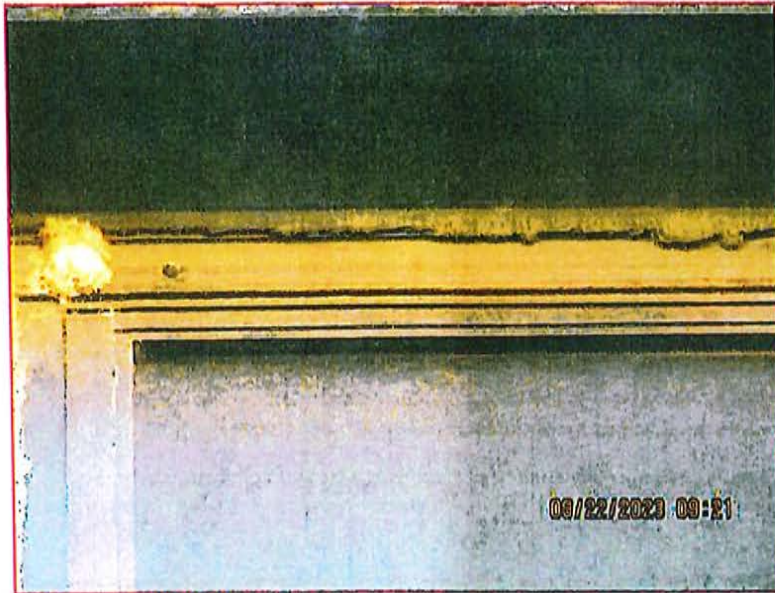
1.2 Item 1(Picture)

Dried, damaged caulking observed at various window. Recommend repairs as needed by a qualified contractor.

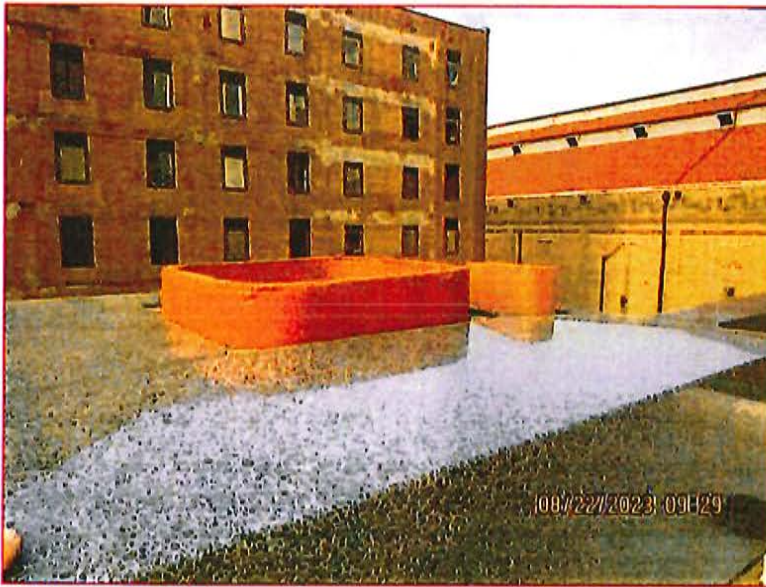
3.3 Item 1(Picture)

No chimney rain cap observed, suggest installing a chimney rain cap to prevent the entrance of the elements, local wildlife, and to preserve the life of the chimney as well as minimize maintenance.

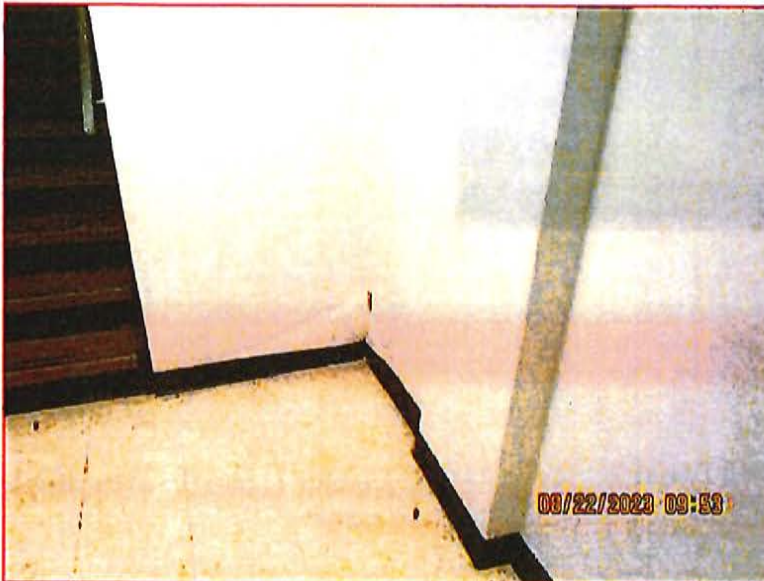
5.3 Item 1(Picture)

Damaged drywall observed in the basement. Recommend review by a Licensed/Qualified professional contractor for repair or replacement as necessary.

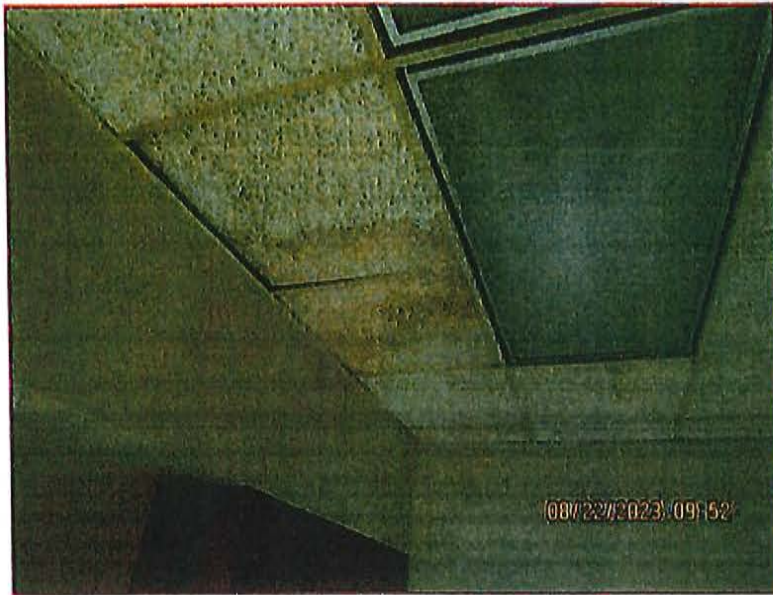
5.4 Item 1(Picture)

Stains observed on the ceiling in the basement. An elevated level of moisture was detected using an electronic moisture meter. A qualified contractor is needed for further review and to perform necessary corrections prior to close.

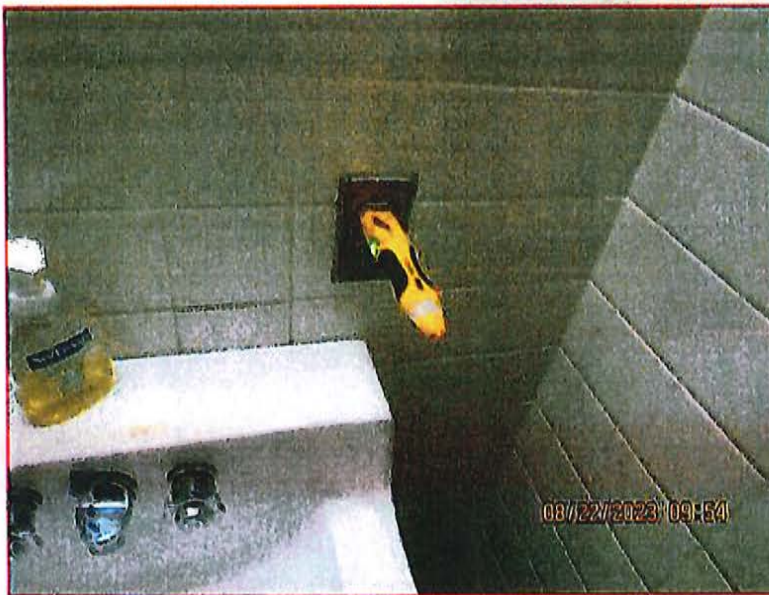
5.10 Item 1(Picture)

Not all receptacles are ground fault circuit interrupter (GFCI) protected. This may not have been required when building was built; client is advised to install ground fault circuit interrupter outlets as a safety enhancement.

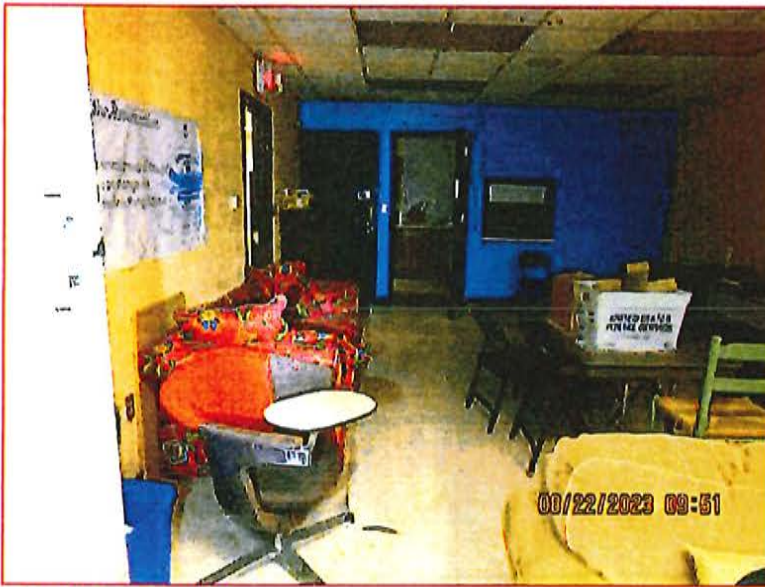
5.15 Item 1(Picture)

Possible asphalt Asbestos observed on basement flooring. Plastic Asbestos, and Vinyl Asbestos floor tiles were sold in 6"x6", 9" x 9" and in some years 12" x 12" sizes. Recommend review for possible removal if client is concerned.

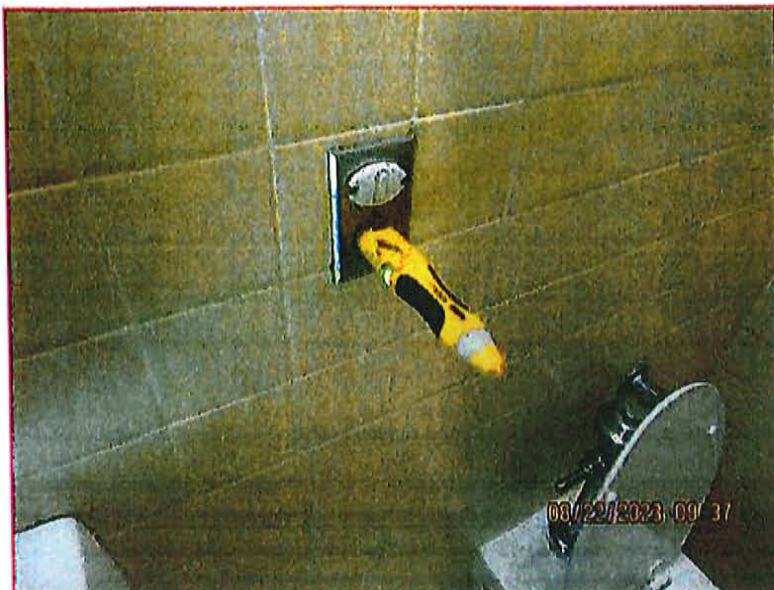
7.7 Item 1(Picture)

A Ground Fault Circuit Interrupter (GFCI) is not present in all upstairs bathrooms, suggest installing GFCI for safety. A qualified electrical contractor is needed for further review and to make necessary repairs/corrections

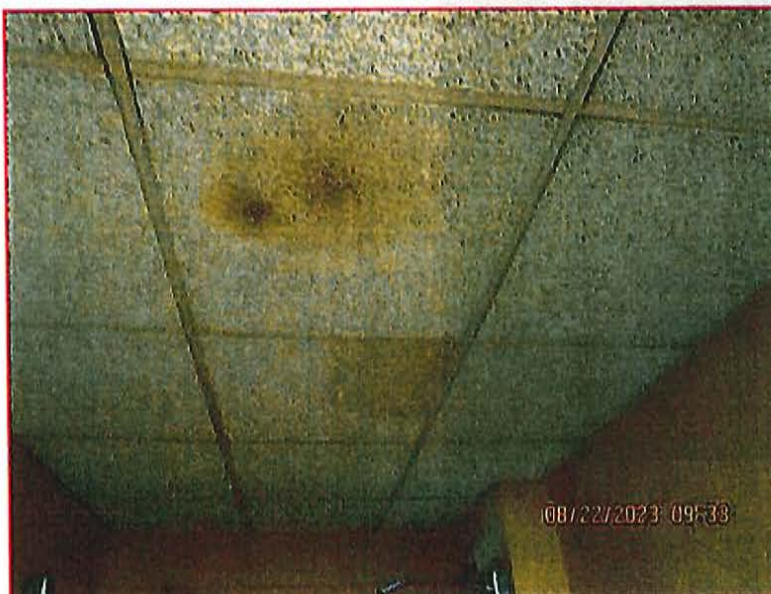
8.2 Item 1(Picture)

Stains observed on ceiling in the 2nd floor hallway. The inspector checked the stains with pin-less non-invasive moisture detector, which showed no moisture present at time of inspection. Client is advised to consult seller to determine the source of staining and verify that corrections have been made.

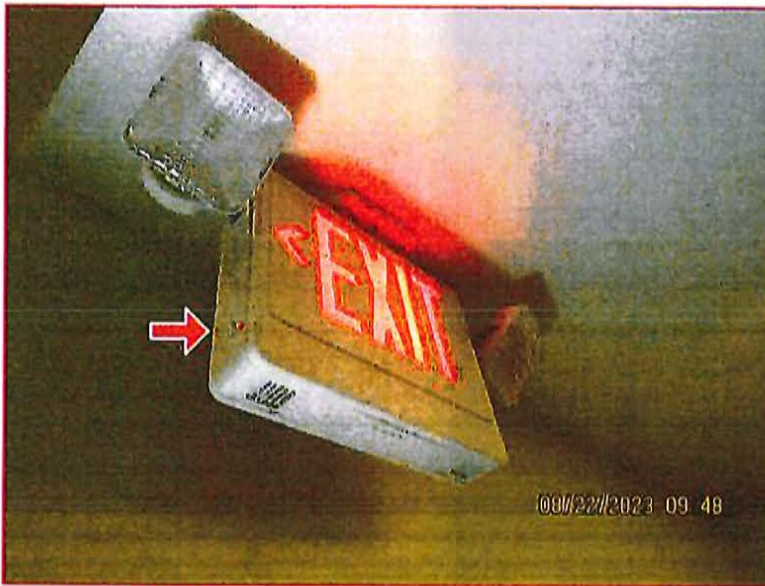
8.7 Item 1(Picture)

Test button at exit did not respond to test. Most likely this is a result of a spent battery. Recommend replacing for safety.

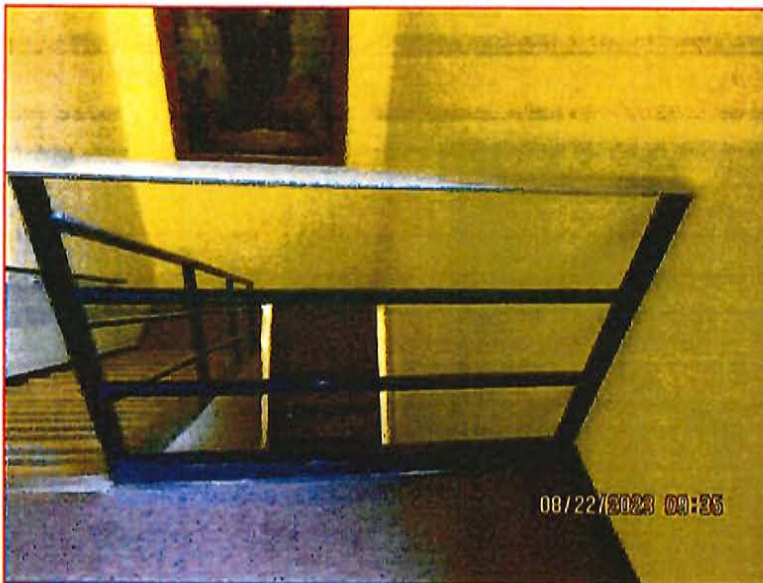
8.10 Item 1(Picture)

Spacing between rails appears larger than 4 inches which may allow small children to crawl through the space. This was observed at stairwell areas. Client may wish to reduce spacing as a child safety enhancement.

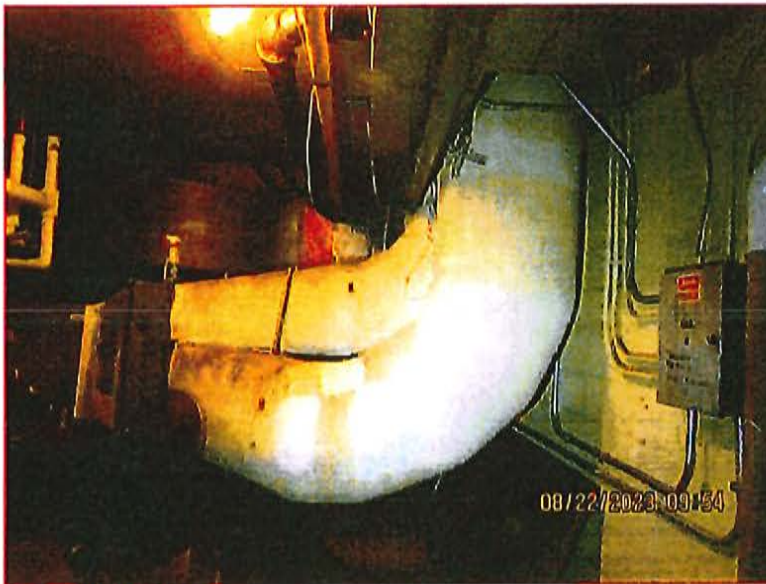
10.5 Item 1(Picture)

Possible asbestos materials observed. The materials appeared to be intact at the time of inspection. Asbestos materials are considered safe by the EPA if they are not disturbed, torn, ripped, or damaged. No torn, ripped, or damaged materials were observed. If client has any concerns regarding asbestos materials, an asbestos testing lab should be consulted for further review to ensure safety.

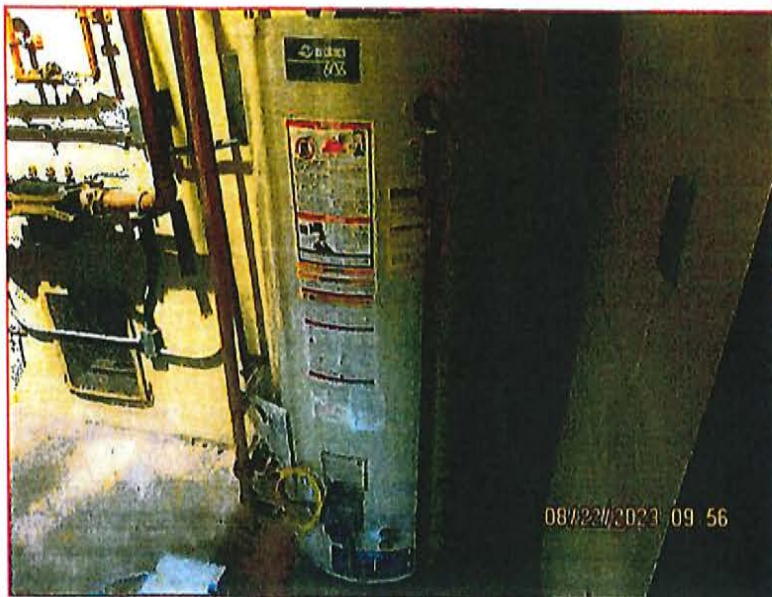
11.0 Item 1(Picture)

The system did operate although isn't a guarantee of future operation. Due to the age of this unit (2003), this system may be at the end of its useful life. A maintenance and performance evaluation should be performed. It is recommended that a qualified licensed plumber service review this system.

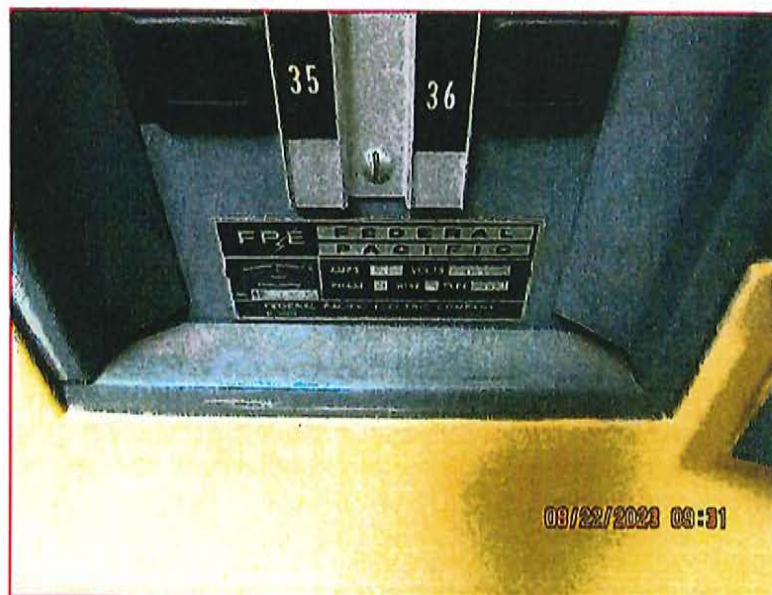
14.2 Item 1(Picture)

(2) You have a Federal Pacific panel which is legal, but there is a possibility that the circuit breakers may not trip when shorted possibly causing an electrical hazard. These were installed in residential and commercial applications. 5 panels were discovered. Federal Pacific is no longer in business. Opinions by licensed electrical contractors on this panel varies between safe and unsafe. I recommend you consult a licensed electrical contractor for an opinion and correct if necessary.
