AMERISPEC[®] INSPECTION SERVICES

Doc #:	82223B	Inspector:	Todd Newman
Date:	8/22/2023		
Dwelling Address:	433 S 5th St Rectory Building Louisville KY 40202		
Client Name:	Archdiocese of Louisville		
Client's Agent:		Real Estate Company:

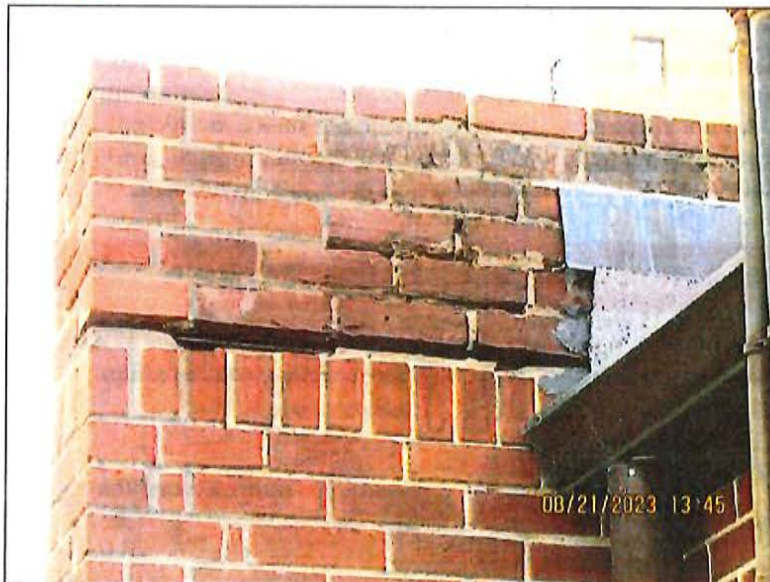
1.0 Item 1(Picture)

Damaged/deteriorated mortar observed at rear of building; suggest tuck pointing as necessary to prevent further damage.

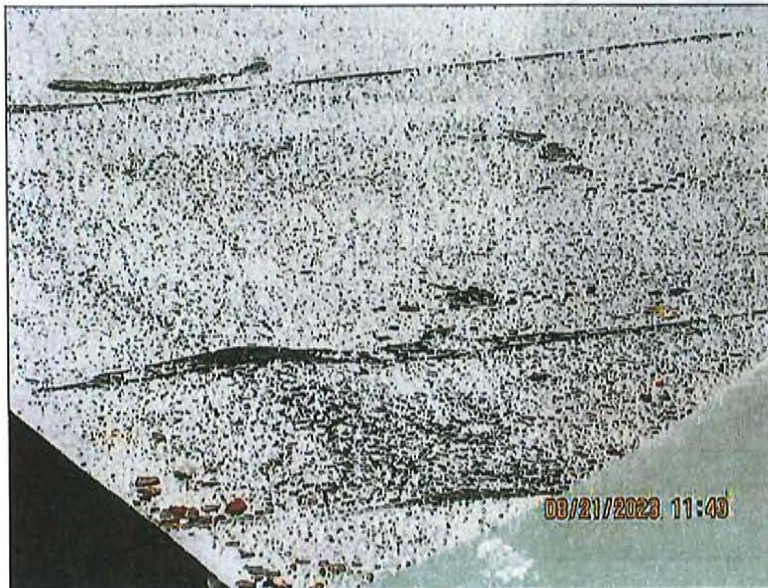
2.0 Item 1(Picture)

Granular loss and deterioration observed at rear of building. Roof is at the end of its useful life. Suggest further review by a licensed roofer prior to closing for repairs/replacement as needed.

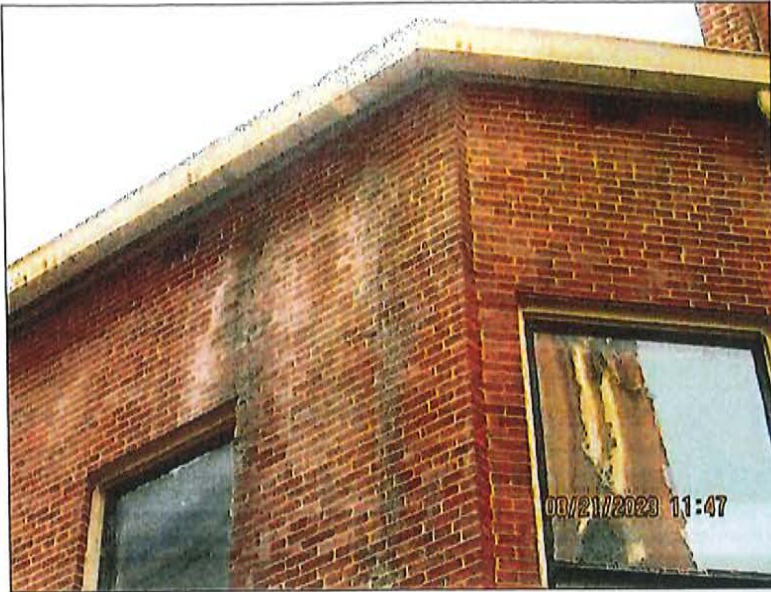
2.1 Item 1(Picture)

Evidence, staining of possible gutter or roof leakage at left side of building. There appears to be past repairs although these may require review. Recommend review and repairs as needed to prevent further water damage by a qualified contractor.

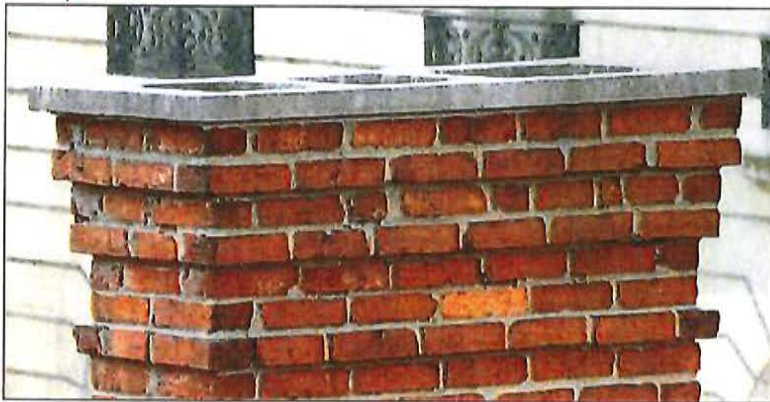
3.0 Item 1(Picture)

(2) Damaged/deteriorated mortar observed on the chimney; suggest tuck pointing as necessary to prevent further damage.

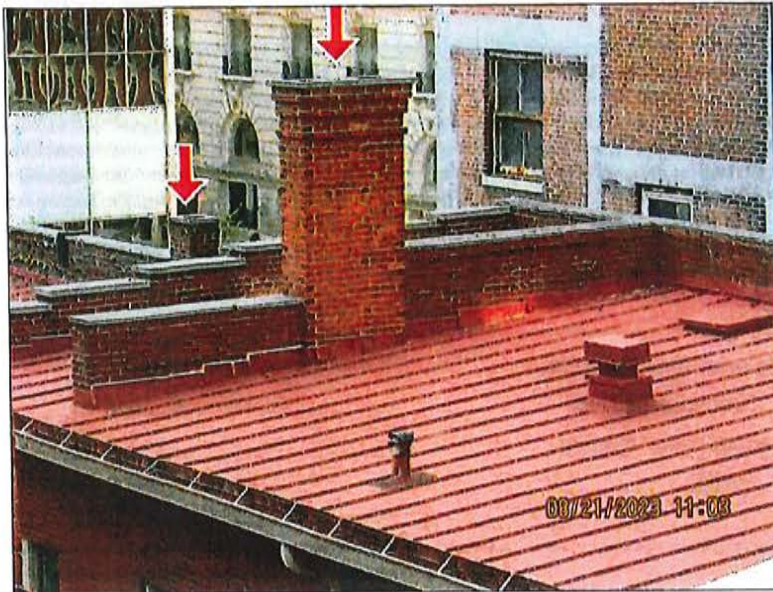
3.3 Item 1(Picture)

(2) No chimney rain cap observed, suggest installing a chimney rain cap to prevent the entrance of the elements, local wildlife, and to preserve the life of the chimney as well as minimize maintenance.

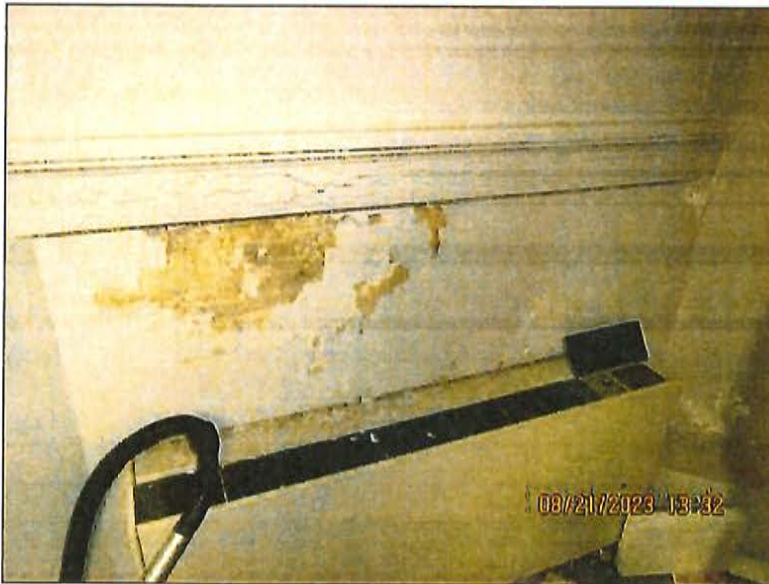
8.1 Item 1(Picture)

Water damaged wall observed at storage area, window areas, rear of building. Recommend review by a Licensed/Qualified professional contractor for repair or replacement as necessary.

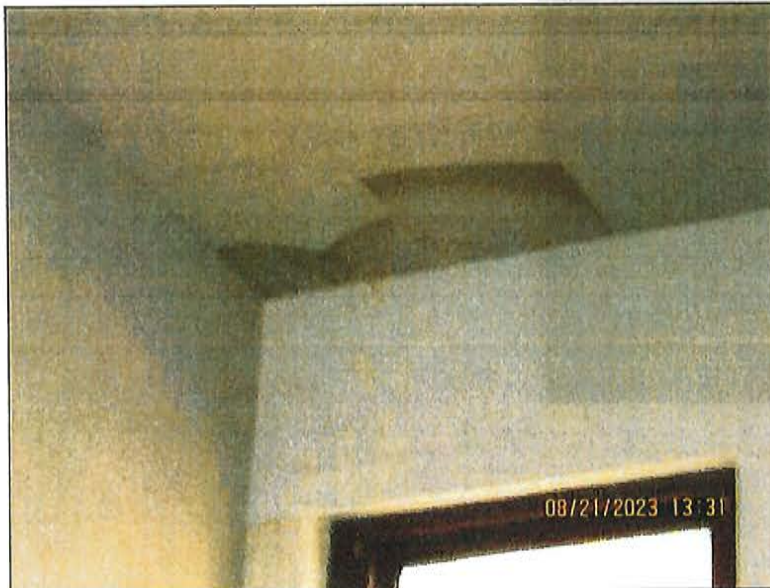
8.2 Item 1(Picture)

(1) Evidence of past water penetration observed at the rear of building. This may be a result of gutter leakage in this area of the building outside. Recommend review sellers disclosure statement or have reviewed by licensed professional for repair or replacement as necessary.

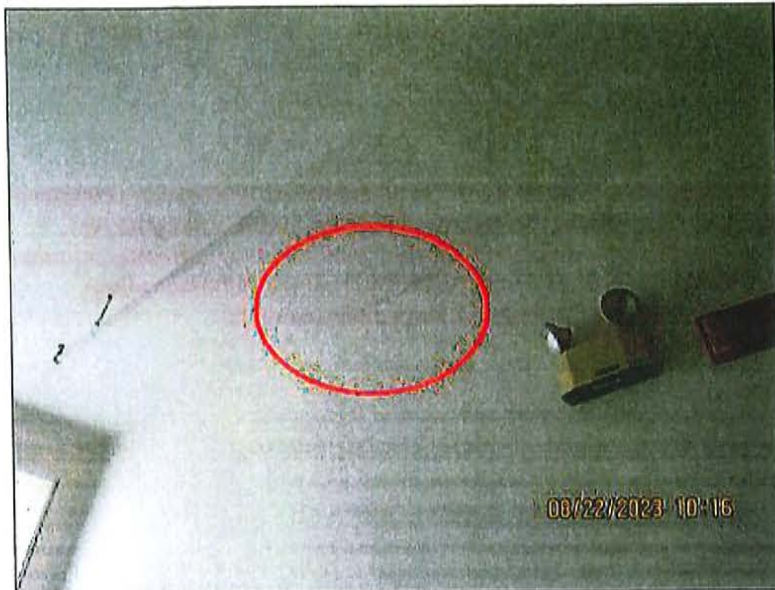
8.2 Item 4(Picture)

(2) Damage/deterioration observed in the hallway. Recommend review by a qualified professional for repair or replacement, as needed.

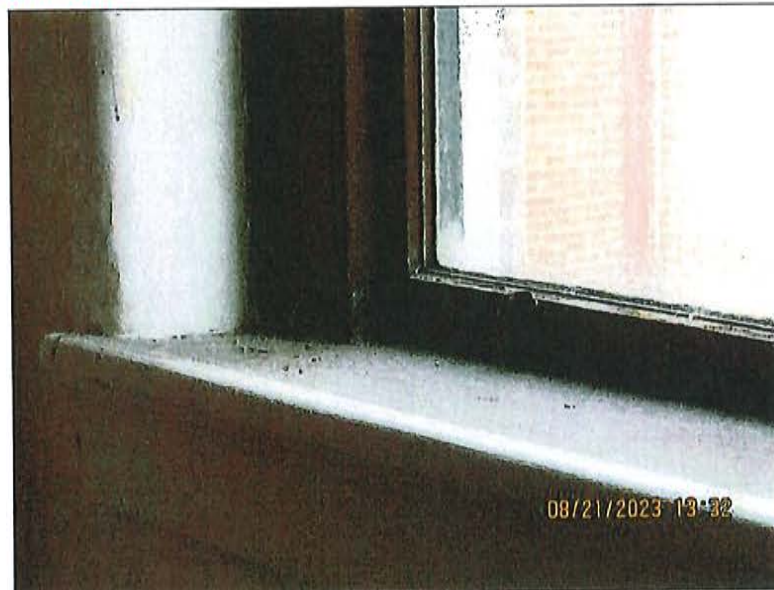
8.5 Item 1(Picture)

Window wood deterioration observed at the rear of the building where leakage has entered. Suggest repairs/replacement as needed.

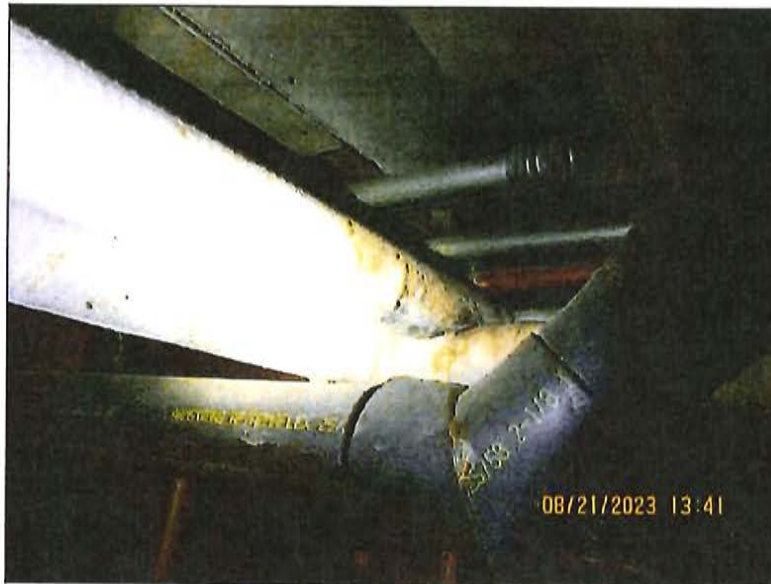
13.0 Item 1(Picture)

Plumbing has mold, water staining. These may be from a past issue with leakage. Recommend review by a licensed plumber if client wishes further evaluation.

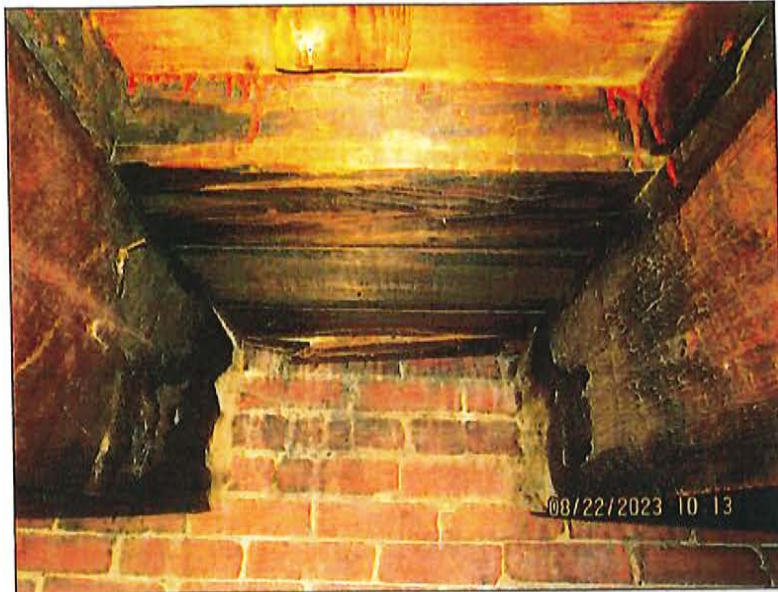
15.2 Item 1(Picture)

Deterioration/damage observed near roof hatch. Recommend review by a qualified professional for repair or replacement.

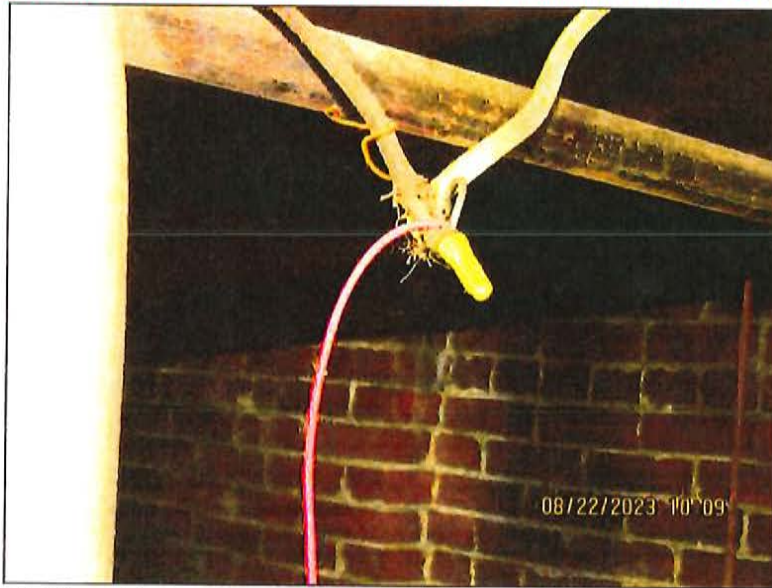
15.6 Item 1(Picture)

Exposed electrical wires observed in the attic. This is a safety concern if used where it could be subject to physical damage. Exposed electrical wires are normally encased in a covered junction box to prevent damage. Recommend review by licensed electrician for removal or encasing in a covered junction box for safety.

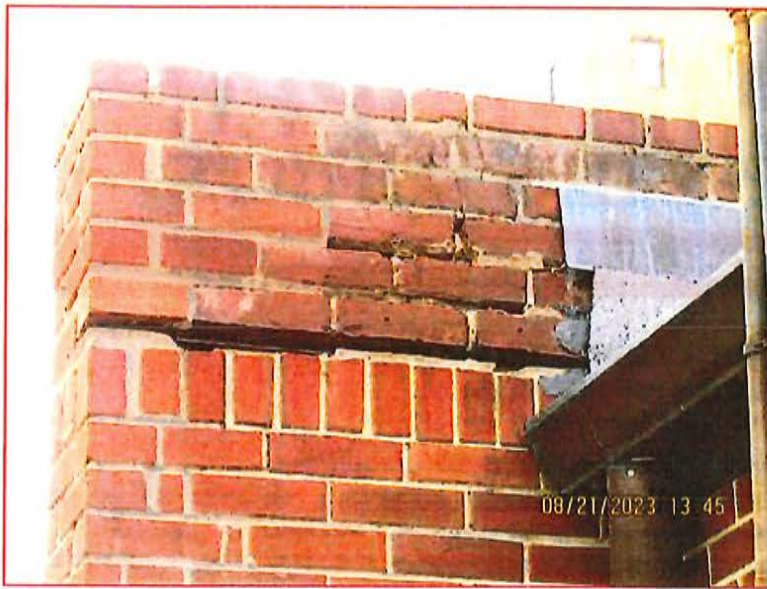
1.0 Item 1(Picture)

Damaged/deteriorated mortar observed at rear of building; suggest tuck pointing as necessary to prevent further damage.

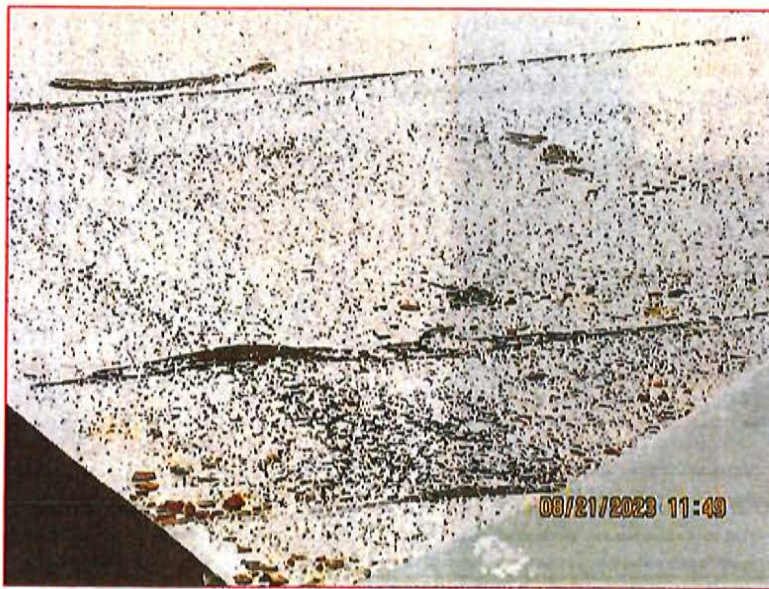
2.0 Item 1(Picture)

Granular loss and deterioration observed at rear of building. Roof is at the end of its useful life. Suggest further review by a licensed roofer prior to closing for repairs/replacement as needed.

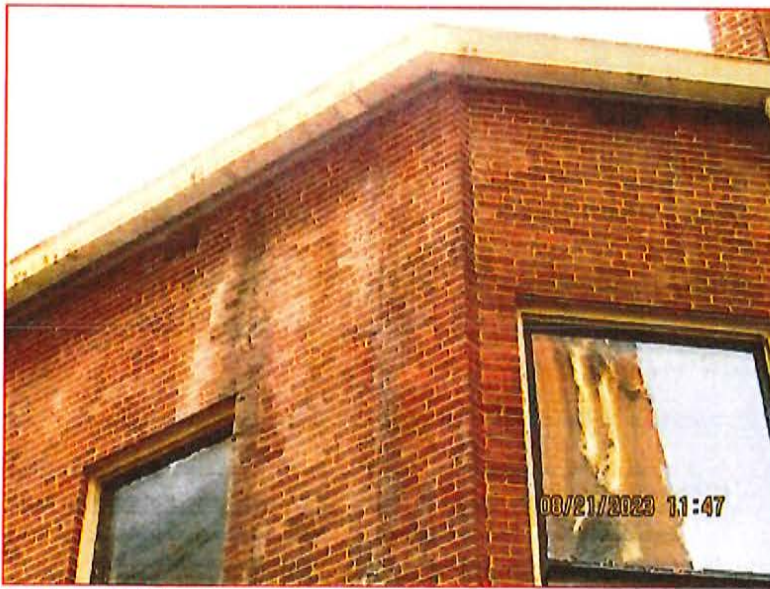
2.1 Item 1(Picture)

Evidence, staining of possible gutter or roof leakage at left side of building. There appears to be past repairs although these may require review. Recommend review and repairs as needed to prevent further water damage by a qualified contractor.

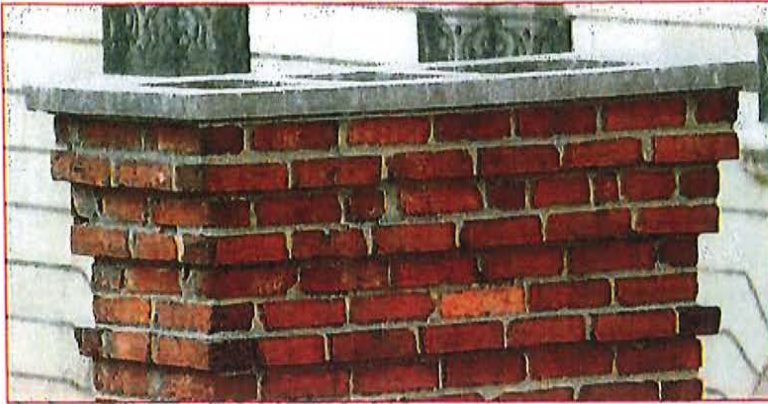
3.0 Item 1(Picture)

(2) Damaged/deteriorated mortar observed on the chimney; suggest tuck pointing as necessary to prevent further damage.

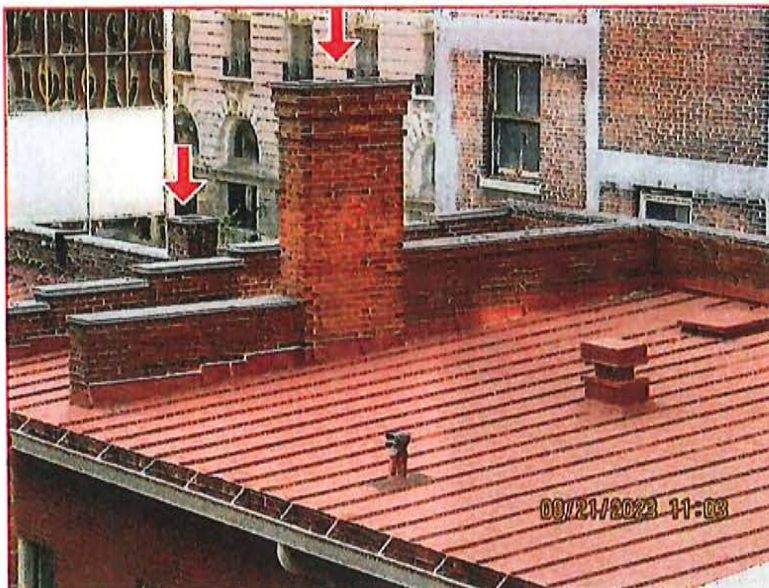
3.3 Item 1(Picture)

(2) No chimney rain cap observed, suggest installing a chimney rain cap to prevent the entrance of the elements, local wildlife, and to preserve the life of the chimney as well as minimize maintenance.

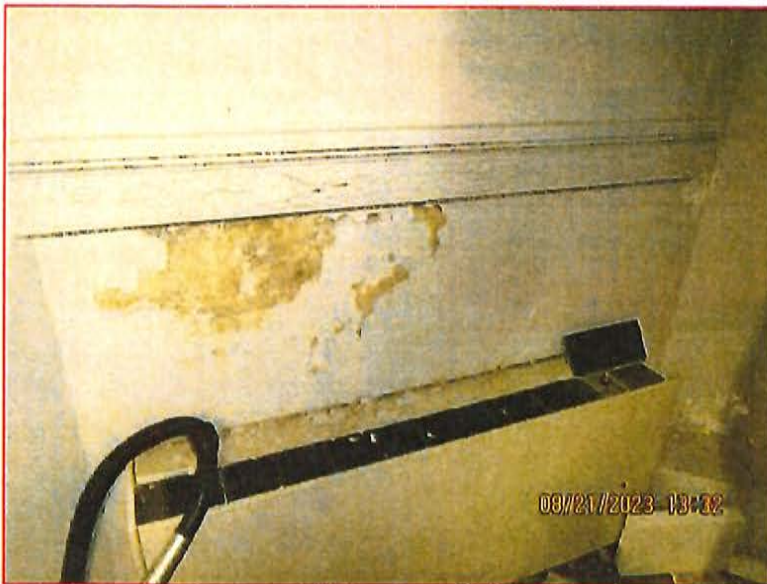
8.1 Item 1(Picture)

Water damaged wall observed at storage area, window areas, rear of building. Recommend review by a Licensed/Qualified professional contractor for repair or replacement as necessary.

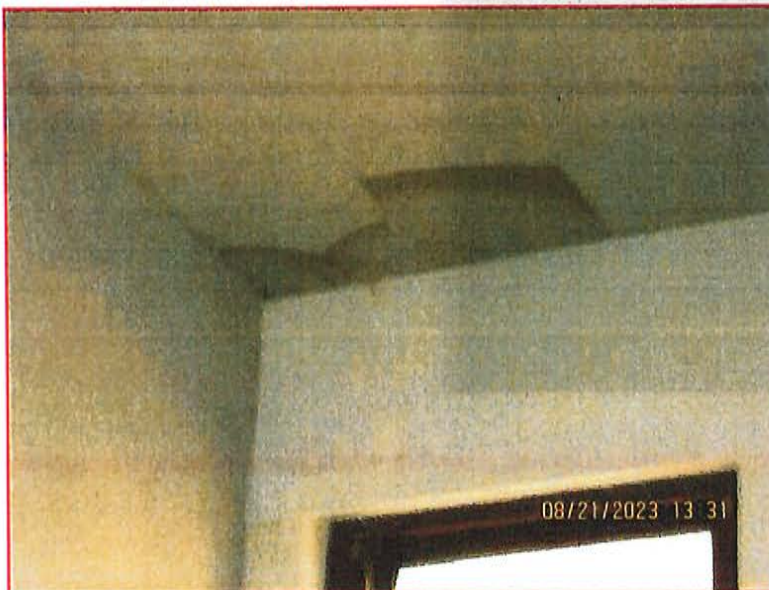
8.2 Item 1(Picture)

(1) Evidence of past water penetration observed at the rear of building. This may be a result of gutter leakage in this area of the building outside. Recommend review sellers disclosure statement or have reviewed by licensed professional for repair or replacement as necessary.

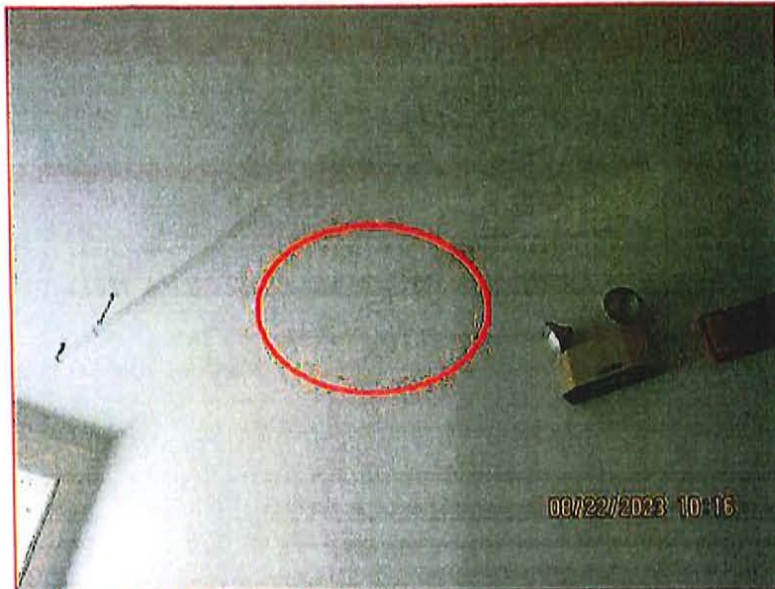
8.2 Item 4(Picture)

(2) Damage/deterioration observed in the hallway. Recommend review by a qualified professional for repair or replacement, as needed.

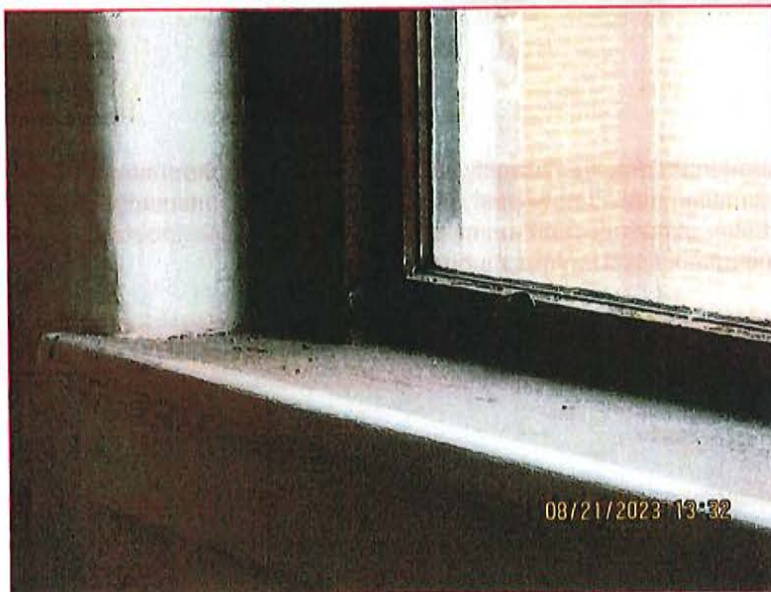
8.5 Item 1(Picture)

Window wood deterioration observed at the rear of the building where leakage has entered. Suggest repairs/replacement as needed.

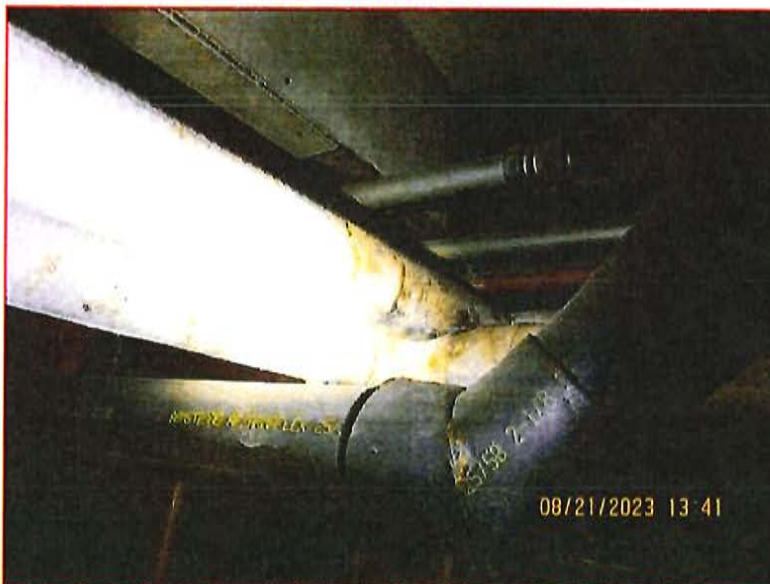
13.0 Item 1(Picture)

Plumbing has mold, water staining. These may be from a past issue with leakage. Recommend review by a licensed plumber if client wishes further evaluation.

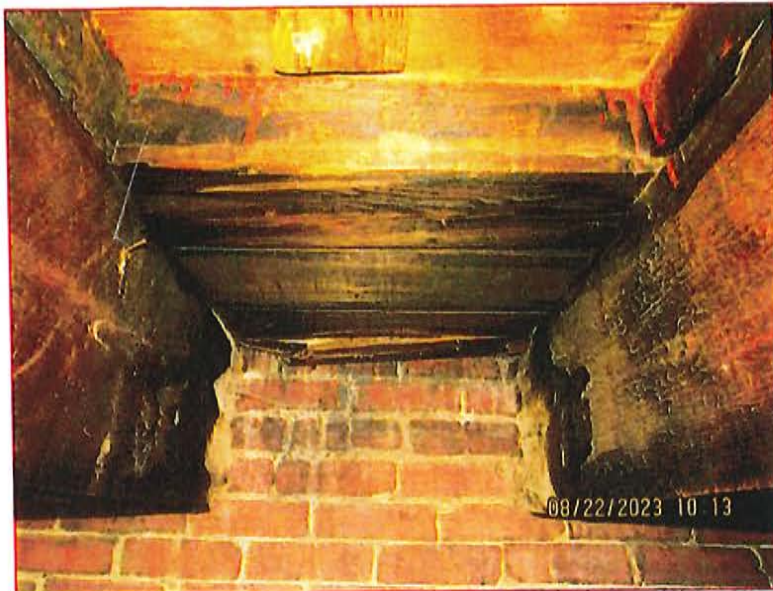
15.2 Item 1(Picture)

Deterioration/damage observed near roof hatch. Recommend review by a qualified professional for repair or replacement.

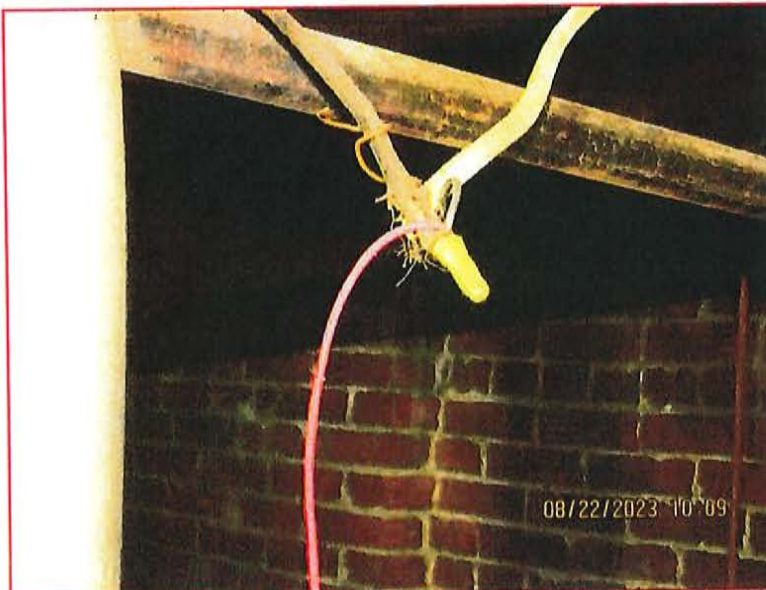
15.6 Item 1(Picture)

Exposed electrical wires observed in the attic. This is a safety concern if used where it could be subject to physical damage. Exposed electrical wires are normally encased in a covered junction box to prevent damage. Recommend review by licensed electrician for removal or encasing in a covered junction box for safety.
